## Appendix A – Limited Capital Plan

| Building Name | St. Theresa's Church |

## Appendix B – Photo Log

Project Title:  
**St. THERESA'S CHURCH MASONRY REPAIRS**

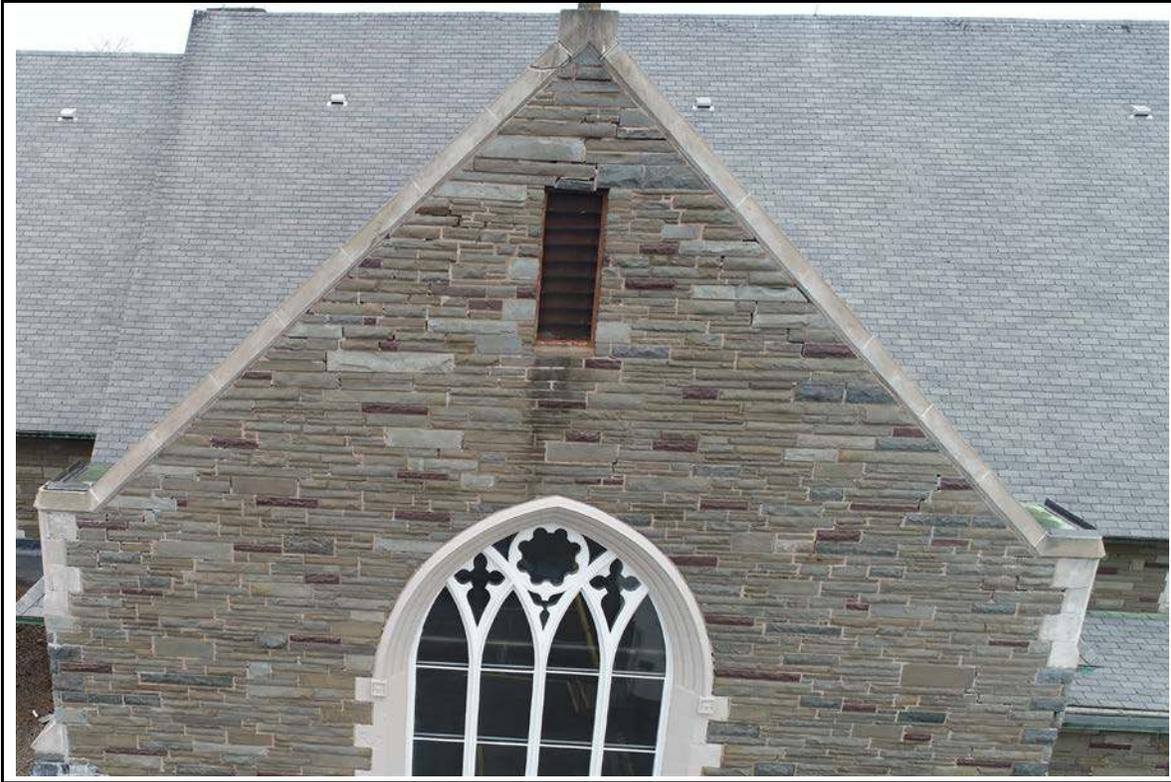
**Photo 5:** West Transept Masonry Deterioration, Absent And Cracked Mortar Dislodged Stone At Vent

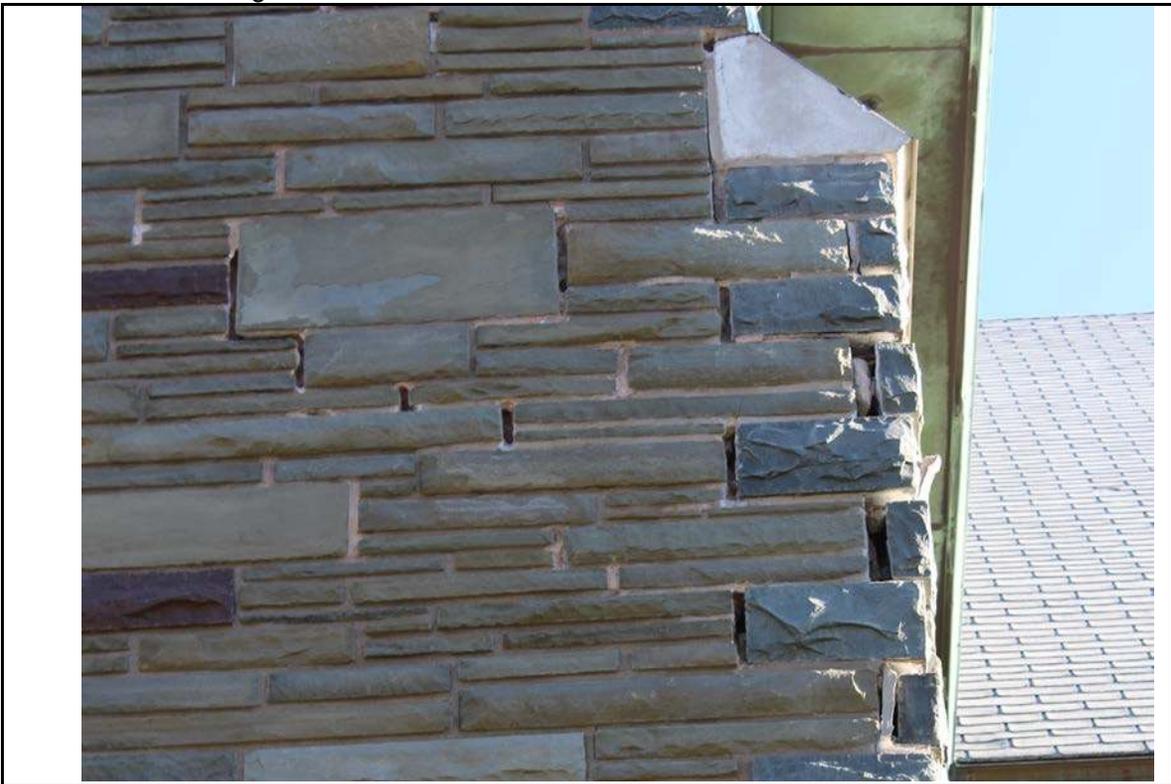
**Photo 6:** South West Transept Corner Absent And Cracked Mortar, Stones With Evidence Of Movement In The Large Mortar Joint

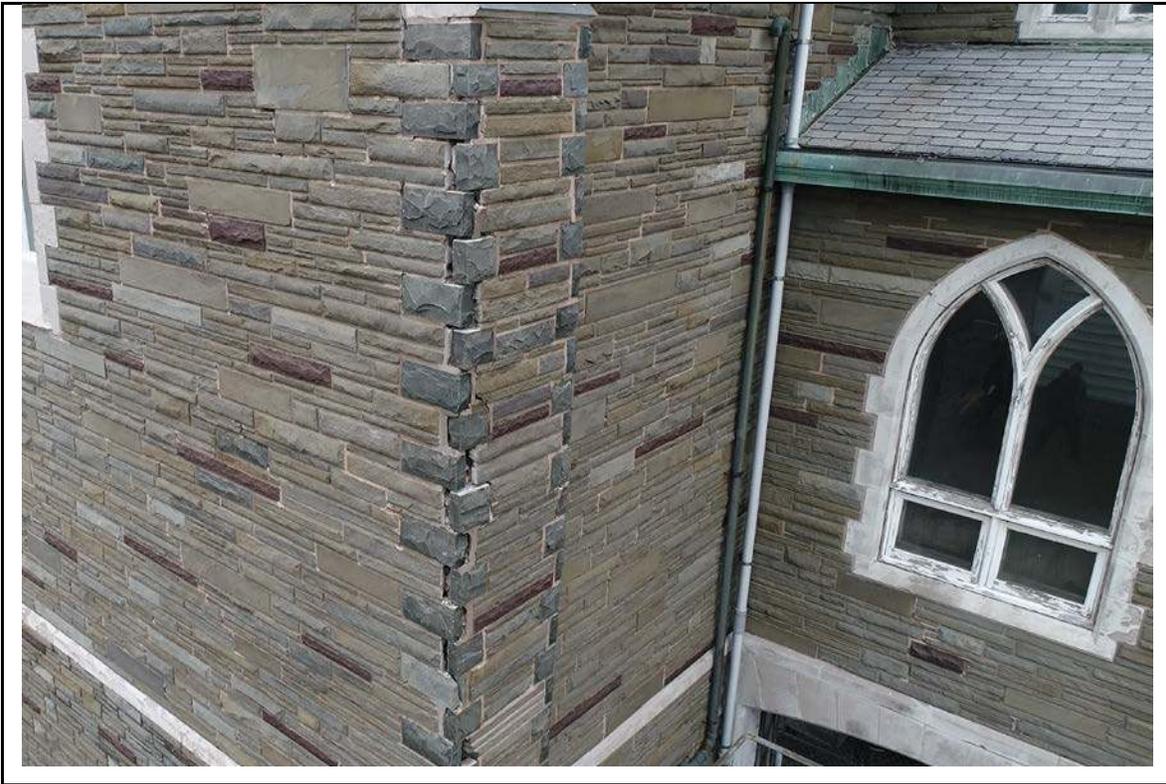
**Photo 7:** South West Transept Corner Looking East Absent And Cracked Mortar, Stones With Evidence Of Past Movement

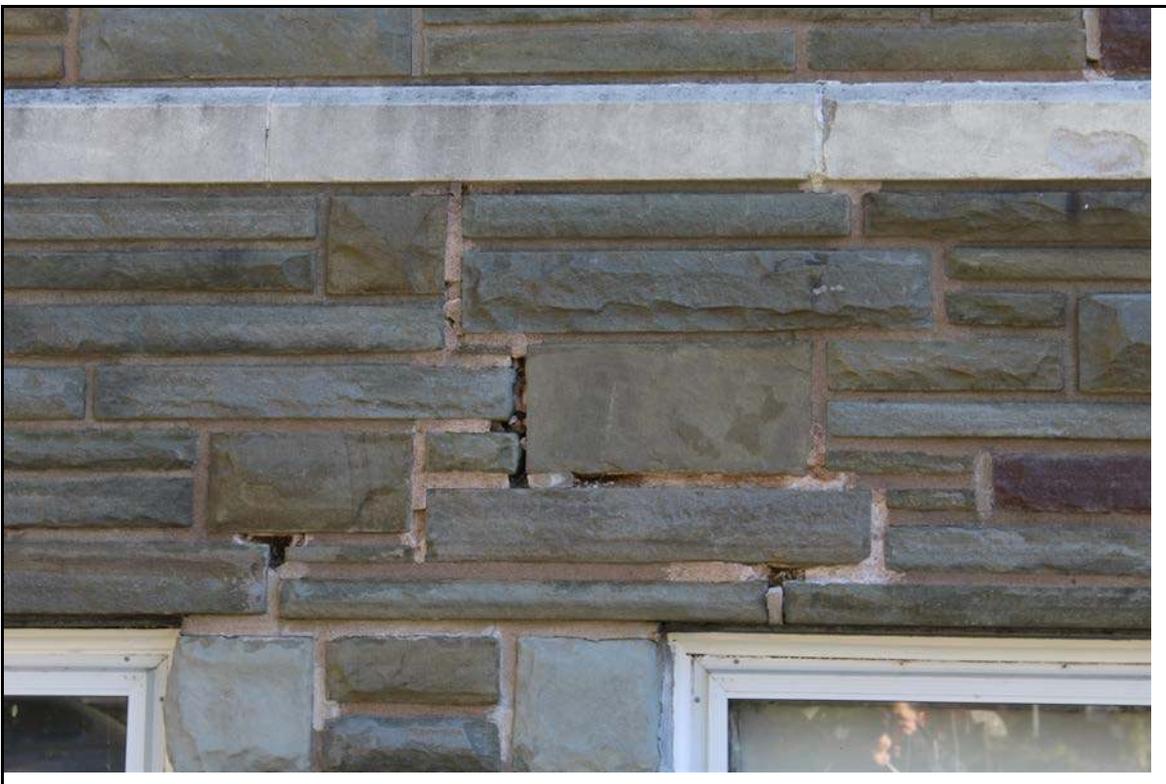
**Photo 8:** West Elevation Below The Sacristy Absent Mortar And Evidence Of Past Repairs

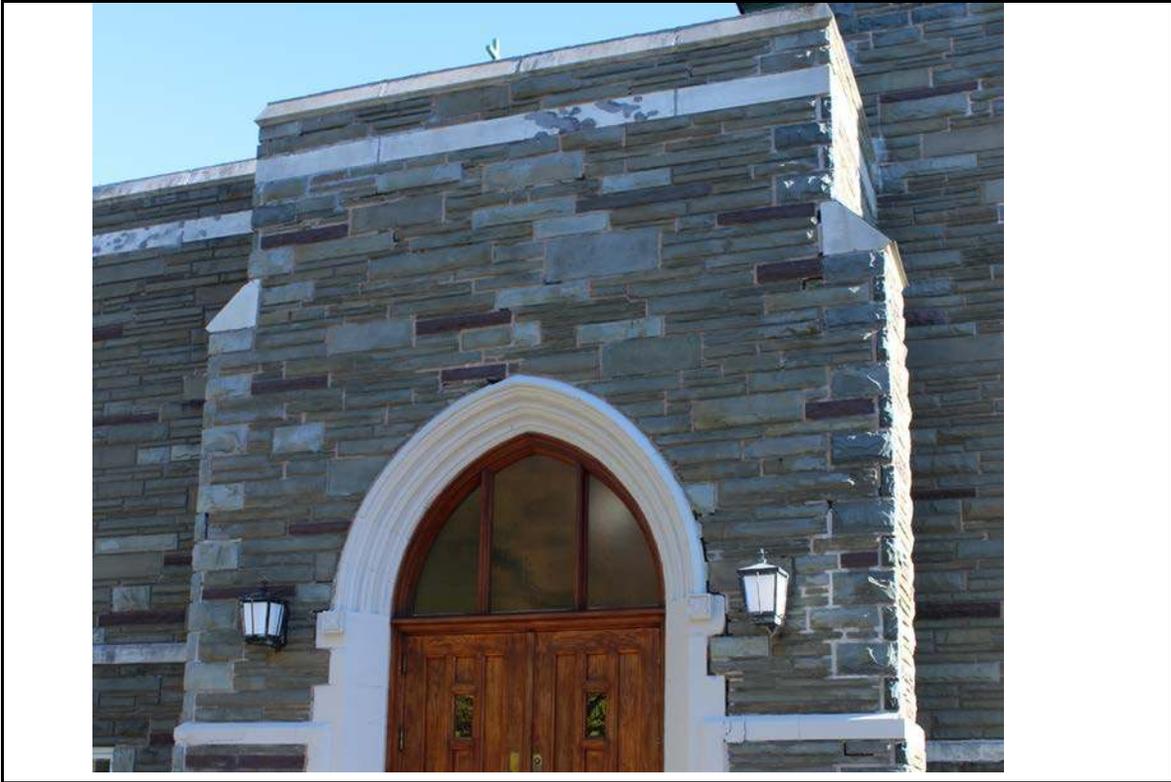
**Photo 9:** West Elevation North Entrance Absent Mortar And Evidence Of Multiple Past Repairs

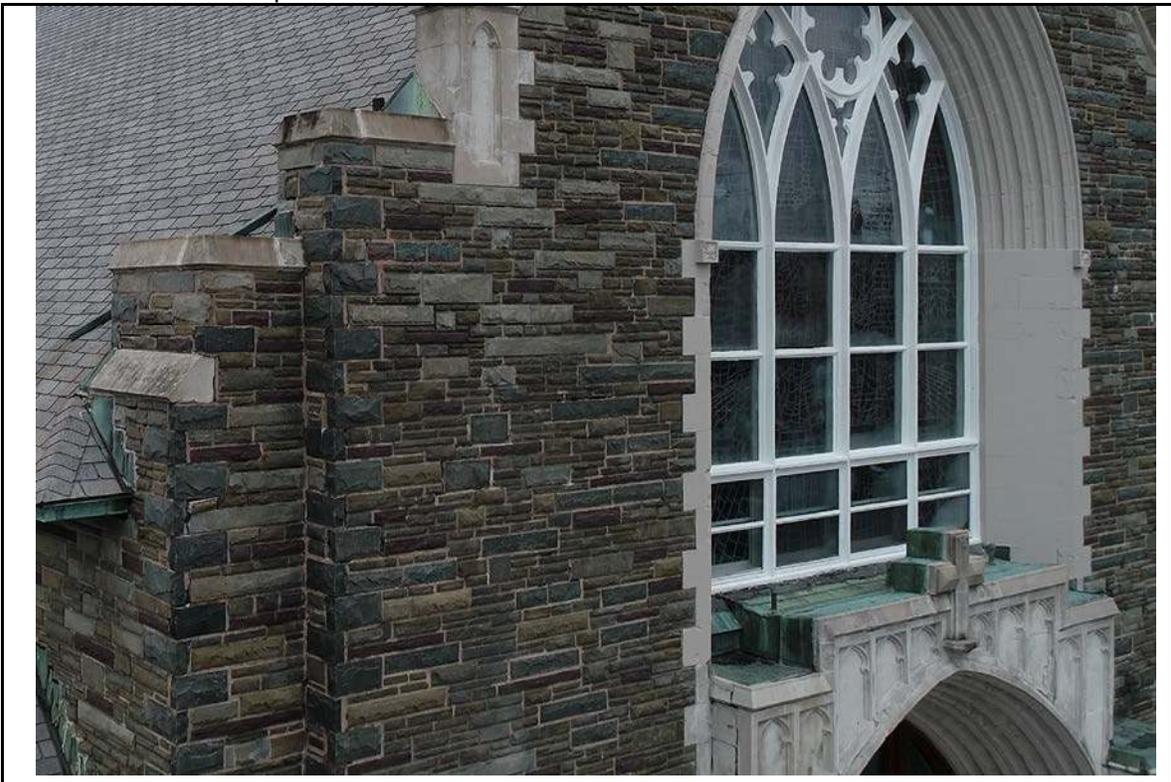
**Photo 10:** Upper South Elevation Absent And Cracked Mortar Dislodged Stones

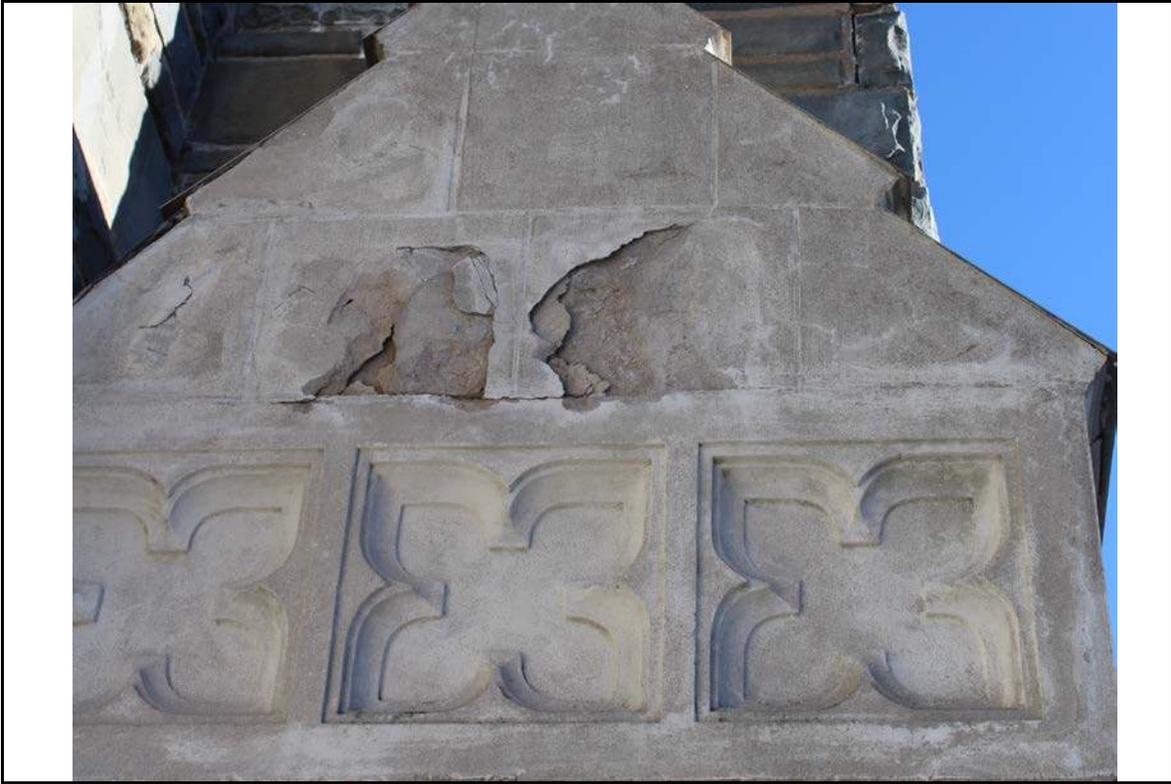
**Photo 11:** Spalling To Special Shapes At The South Elevation

| Component | Uniformat Code | Recapitalization Detail | Year of Installation or Repair | Expected Useful Life (EUL) | Current Age | Theoretical Remaining Useful Life (RUL) | Useful Life Corrected For Observations | Year of Replacement | Type of event (Cyclic/Single) | Unit | Quantity | Unit Cost | Total Cost |
|--|---|---|---|---|---|---|--|---|---|---|---|---|---|
| Special Shapes Allowance | B2010 - Exterior Walls | Allowance for replacement of damaged special shapes | 1957 | 60 | 62 | -2 | 0 | 2019 | Cyclical | LS | 1 | \$ 100,000.00 | \$ 100,000 |

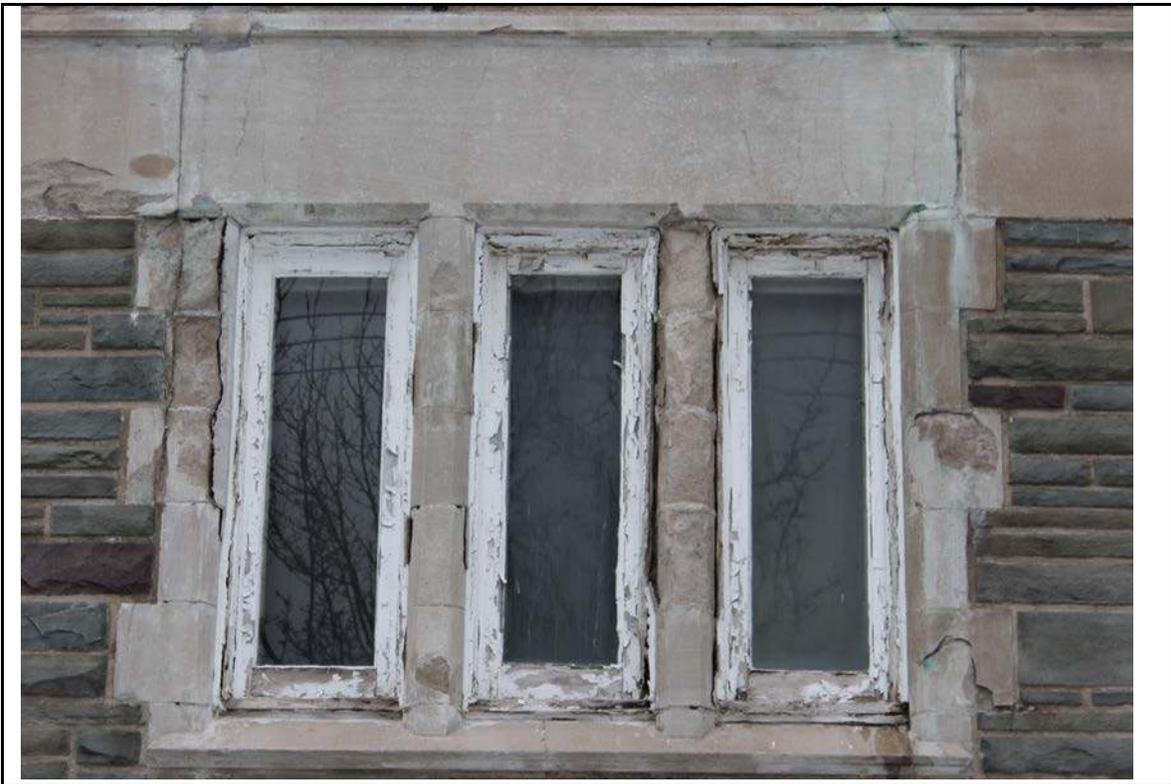
**Photo 12:** Spalling To Special Shapes At The South Elevation Deteriorated Windows

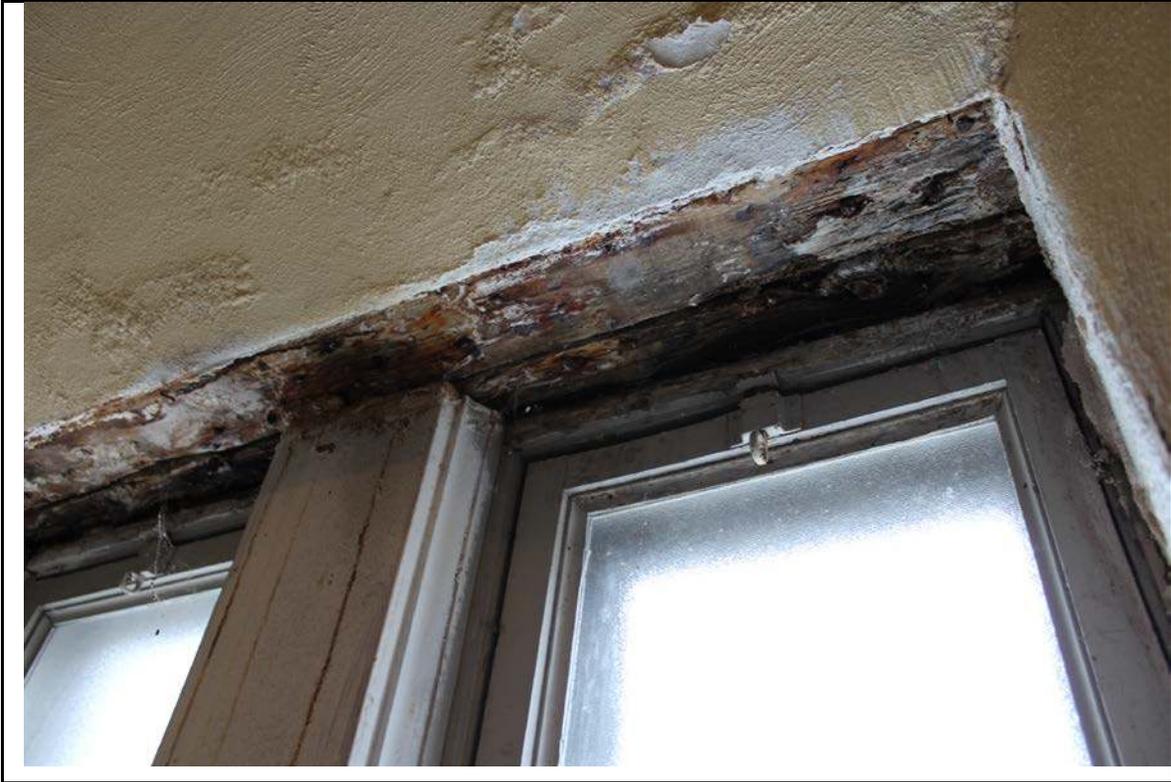
**Photo 13:** Long Term Interior Deterioration At The Window Shown In Photo 12

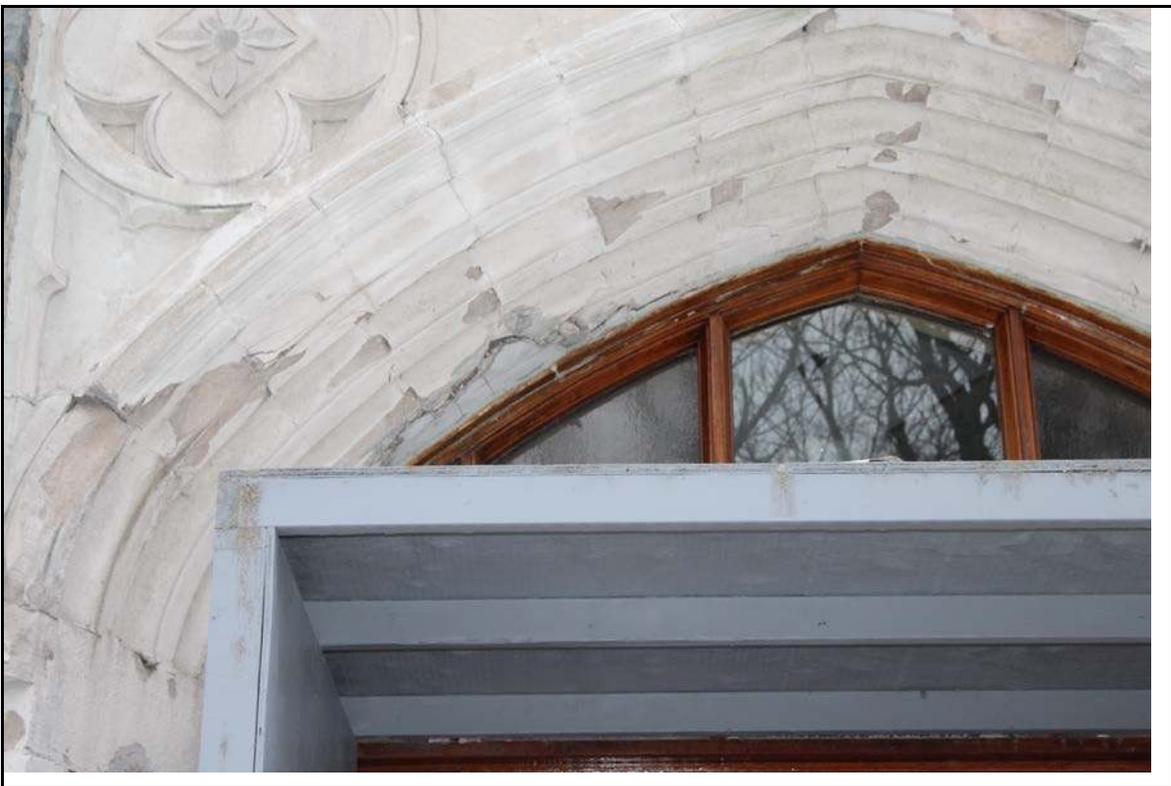
**Photo 14:** East Elevation South Entrance Spalling To Special Shapes

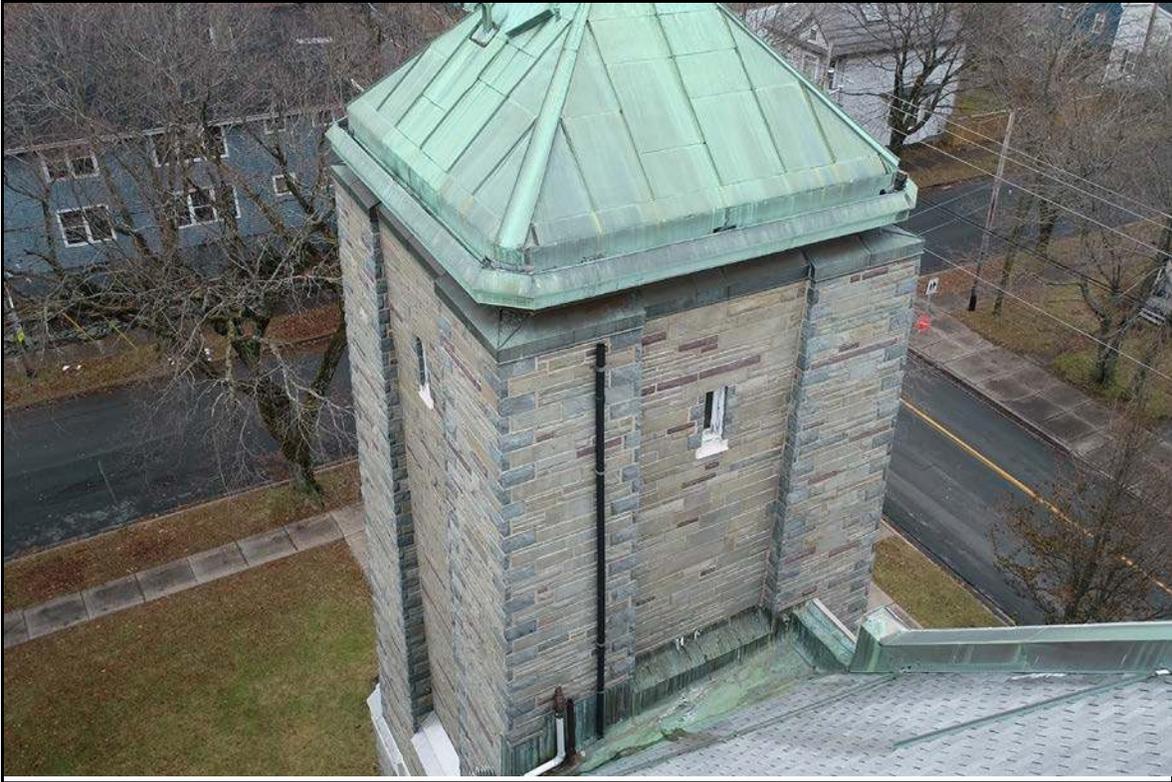
**Photo 15:** Bell Tower From Above Looking South East In Good Condition

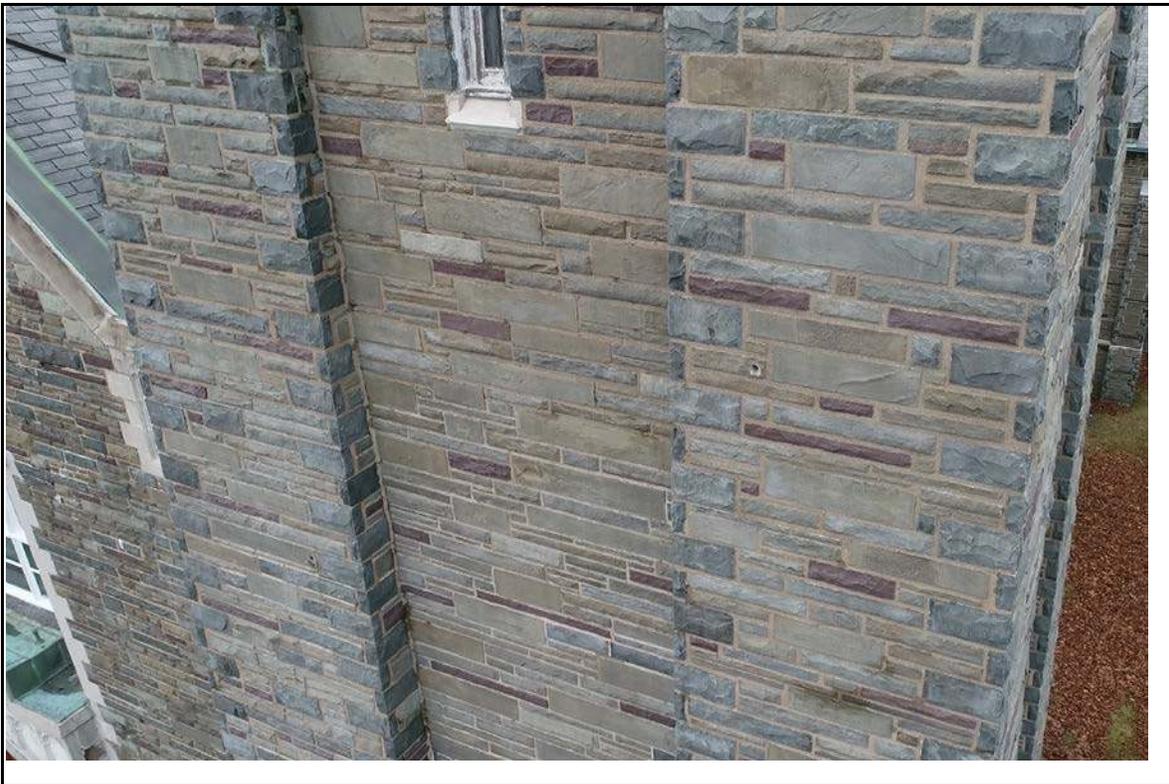
**Photo 16:** Bell Tower South Elevation From Above Mortar in Good Condition

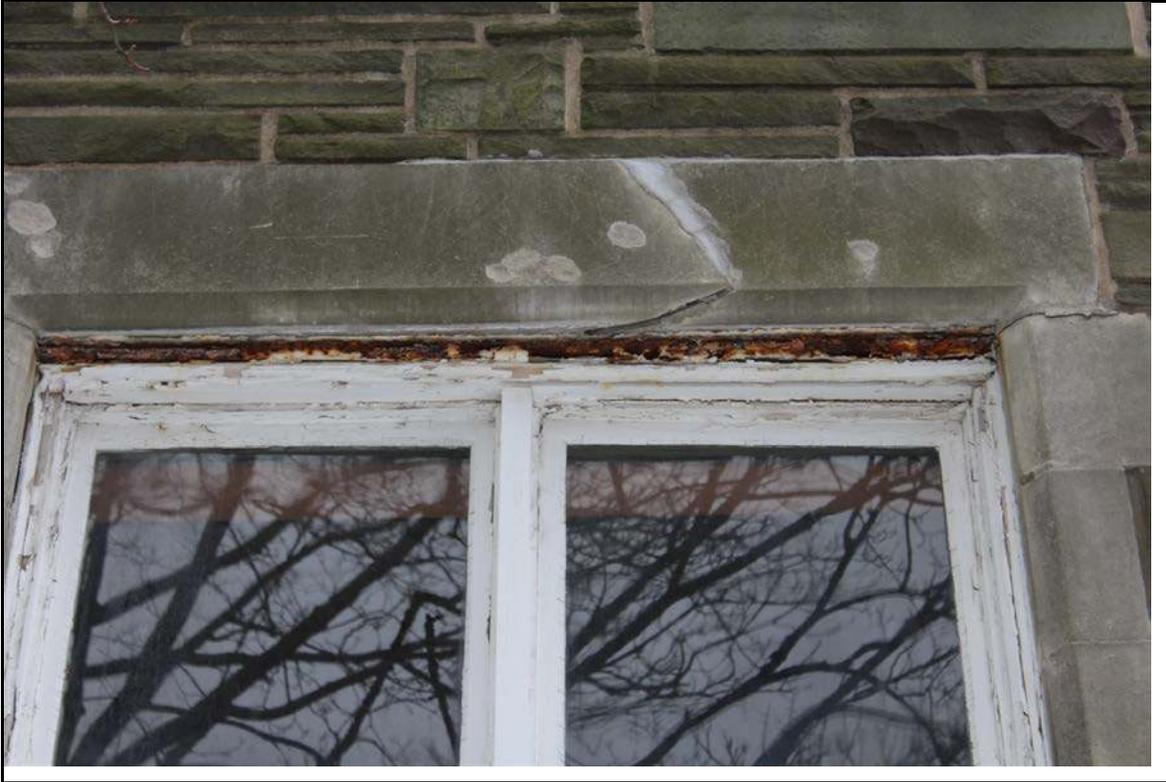
**Photo 17:** East Elevation Damaged Stone And Corroded Steel Lintel

| Component | Uniformat Code | Recapitalization Detail | Year of Installation or Repair | Expected Useful Life (EUL) | Current Age | Theoretical Remaining Useful Life (RUL) | Useful Life Corrected For Observations | Year of Replacement | Type of event (Cyclic/Single) | Unit | Quantity | Unit Cost | Total Cost |
|--|---|---|---|---|---|---|--|---|---|---|---|---|---|
| Steel Lintels | B2010 - Exterior Walls | Replace the steel lintels with new during reconstruction | 1957 | 60 | 62 | -2 | 3 | 2022 | Cyclical | Lft | 180 | \$ 12.00 | \$ 2,160 |

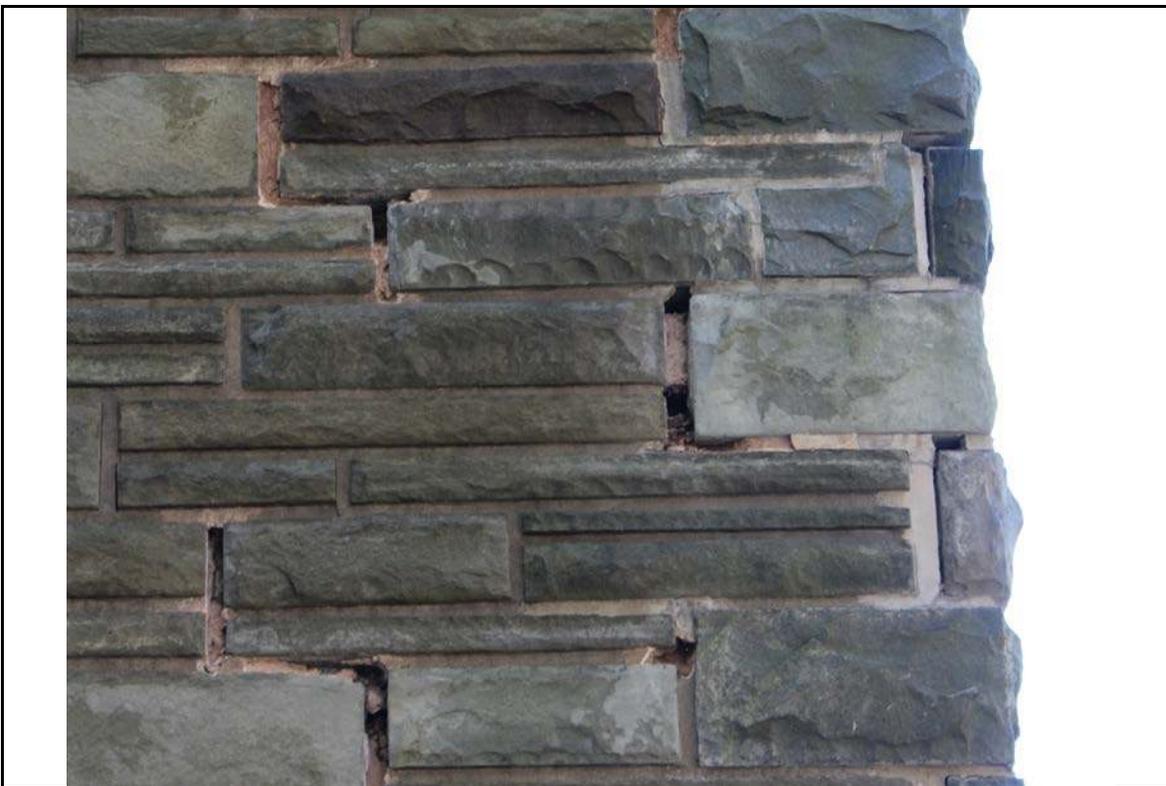
**Photo 18:** North Elevation Absent Mortar and Past Repairs

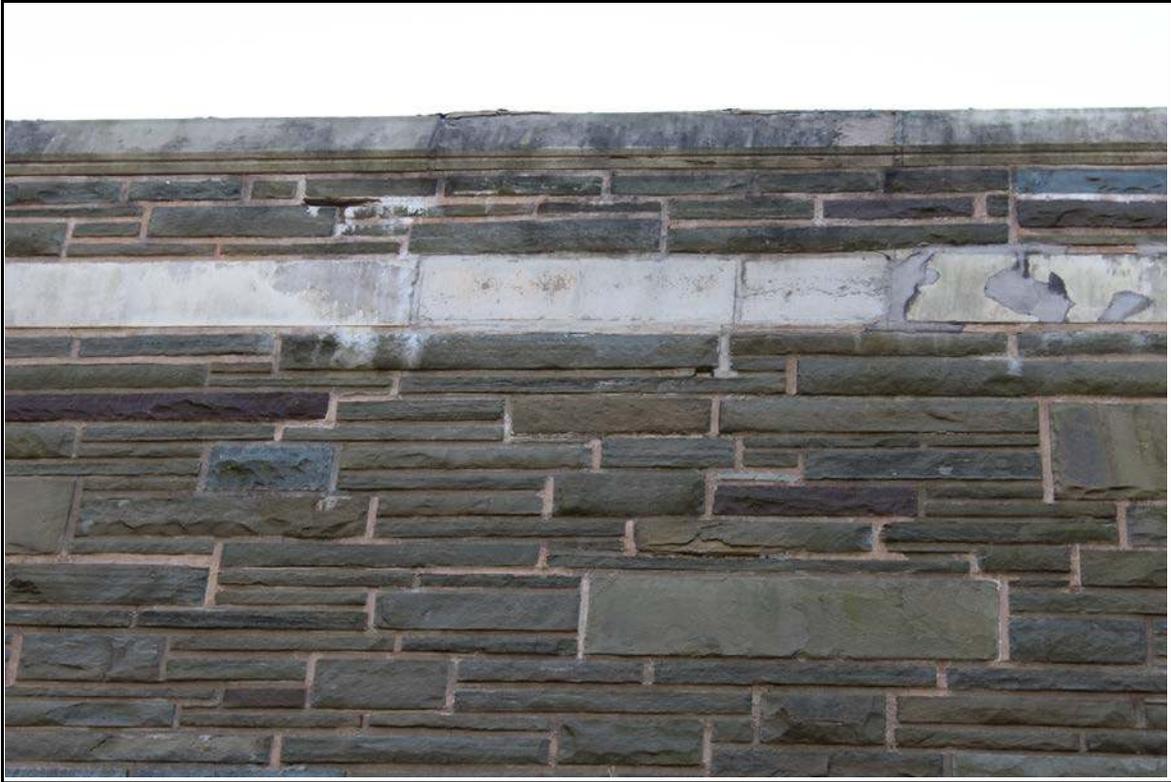
**Photo 19:** North Elevation Efflorescence And Damaged Special Shapes

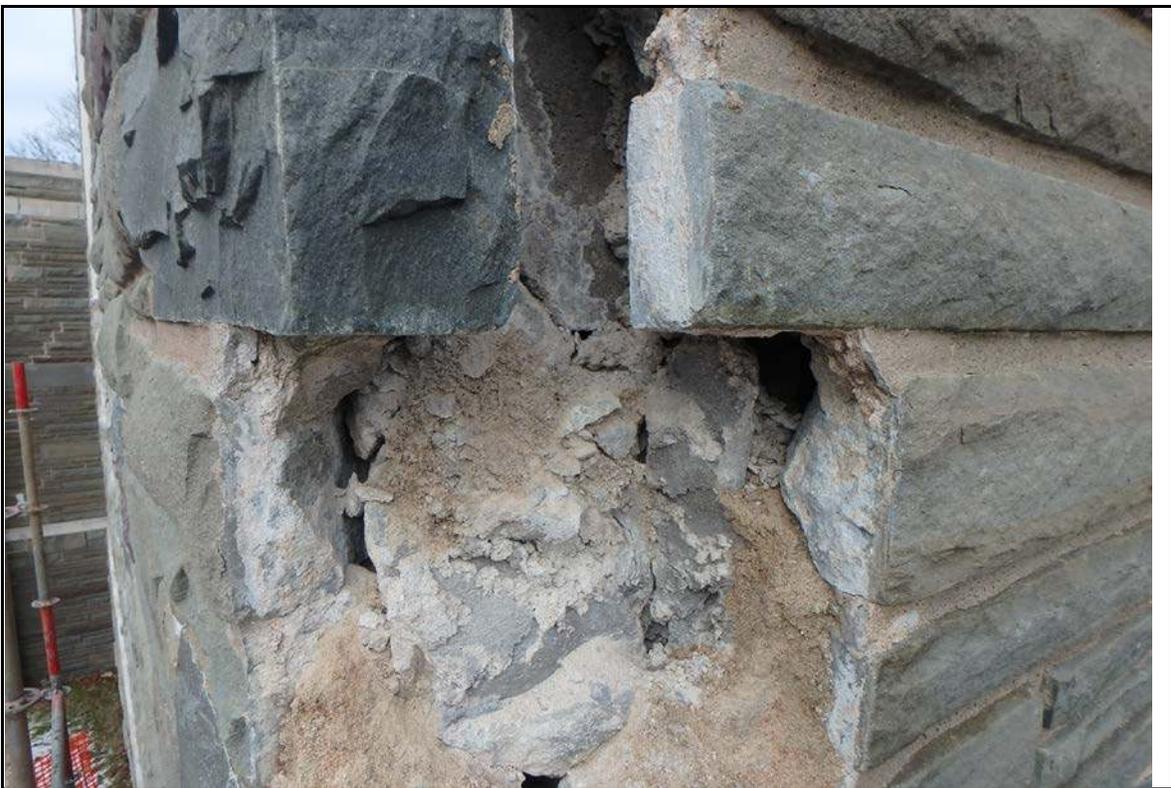
**Photo 20:** Intrusive Investigation West Elevation Corner, Evidence Of Movement In The Gap Between The Stone And Concrete Block Behind

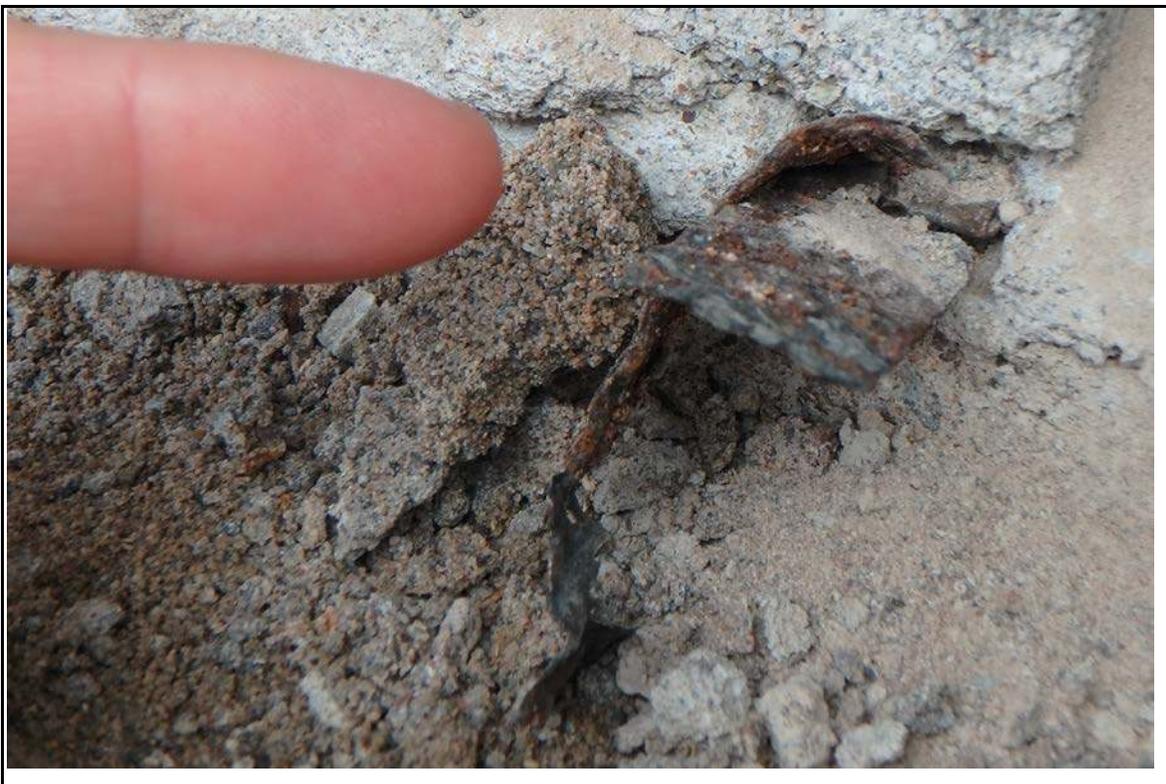
**Photo 22:** Corroded Brick Tie

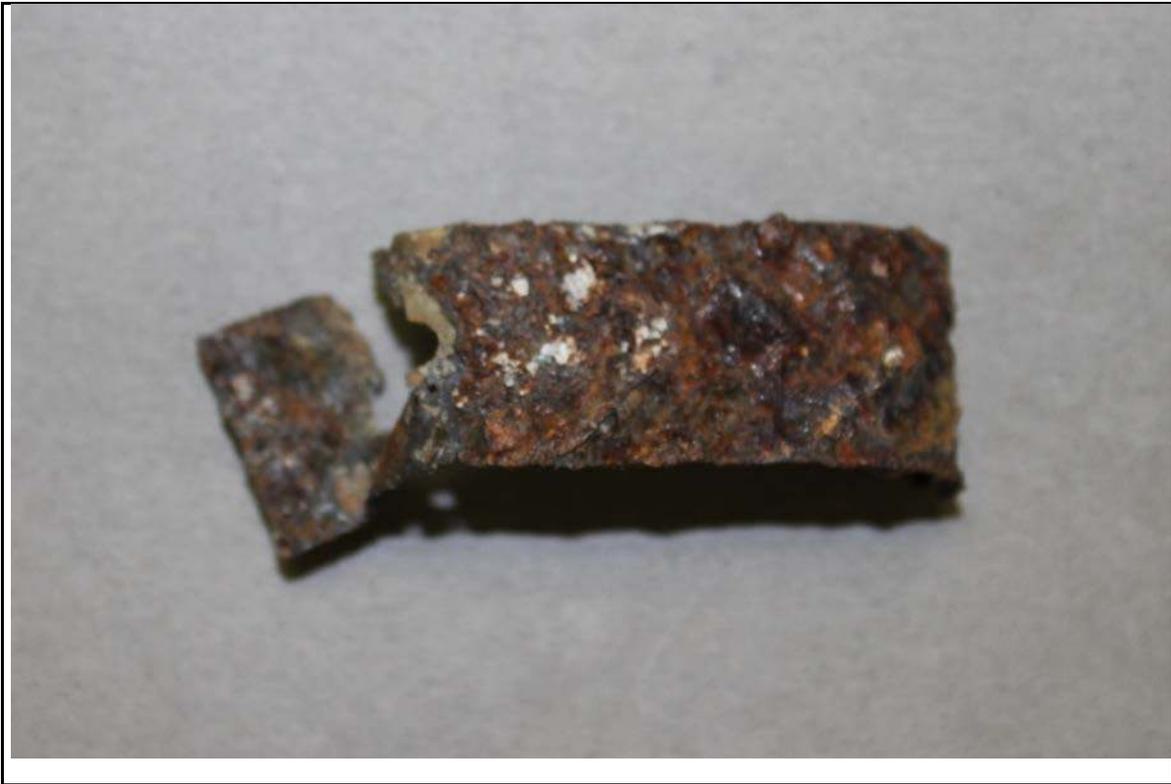
**Photo 23:** Corroded Brick Tie Removed From Wall During Intrusive Investigation

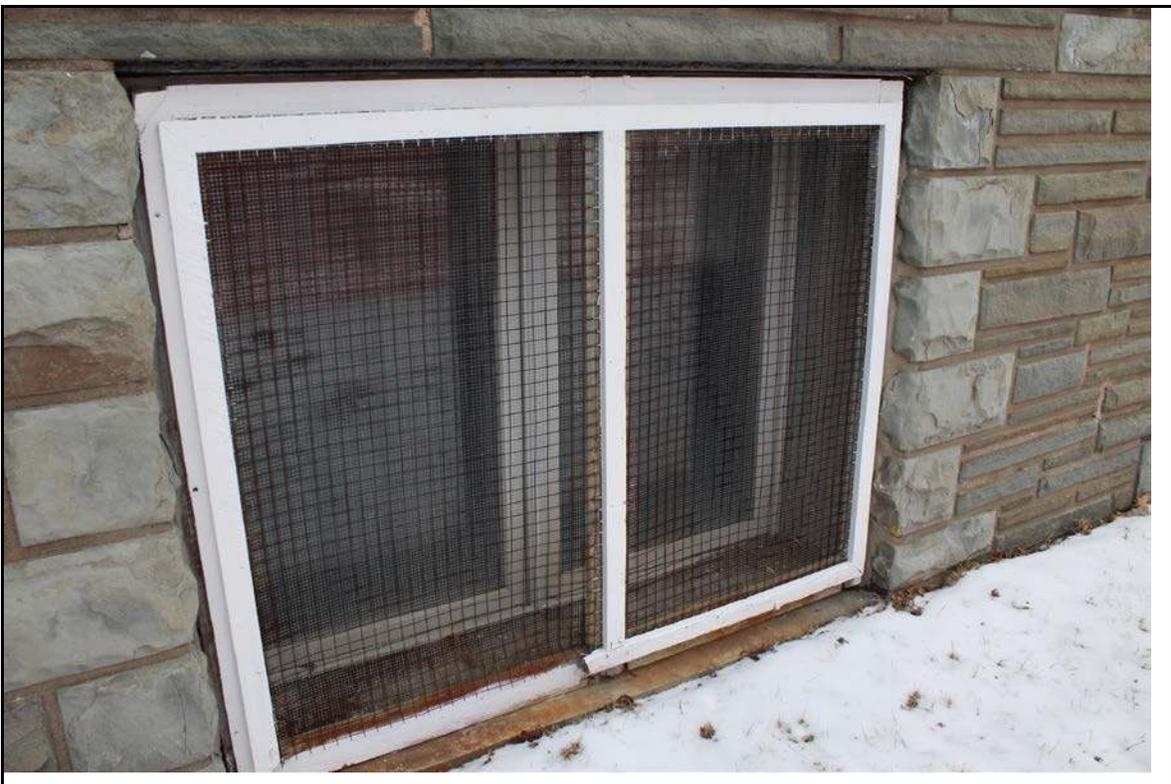
**Photo 24:** W1 West Elevation Typical Condition

| Component | Uniformat Code | Recapitalization Detail | Year of Installation or Repair | Expected Useful Life (EUL) | Current Age | Theoretical Remaining Useful Life (RUL) | Useful Life Corrected For Observations | Year of Replacement | Type of event (Cyclic/Single) | Unit | Quantity | Unit Cost | Total Cost |
|--|---|---|---|---|---|---|--|---|---|---|---|---|---|
| W1- Basement Hall Windows | B2020 - Exterior Windows | Replace basement windows at end of life | 1980 | 30 | 39 | -9 | 20 | 2039 | Cyclical | Ea | 10 | \$ 2,000.00 | \$ 20,000 |

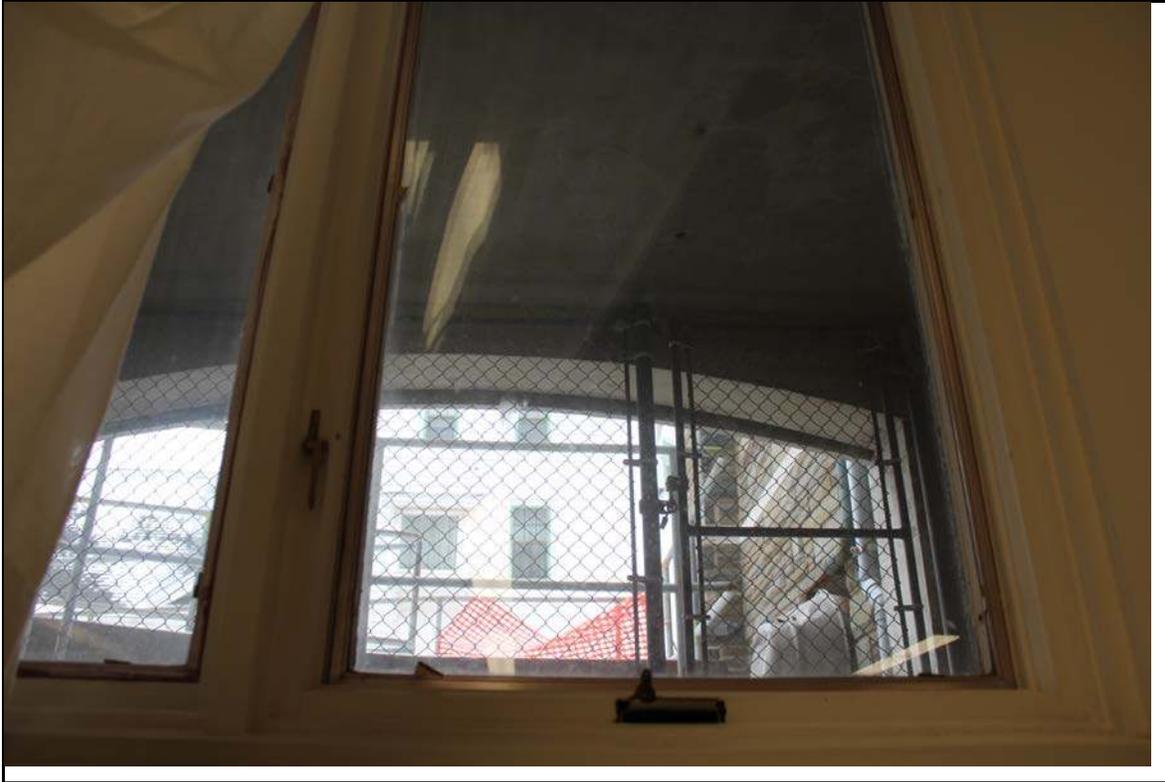
**Photo 25:** W1 From The Interior West Elevation Typical Condition

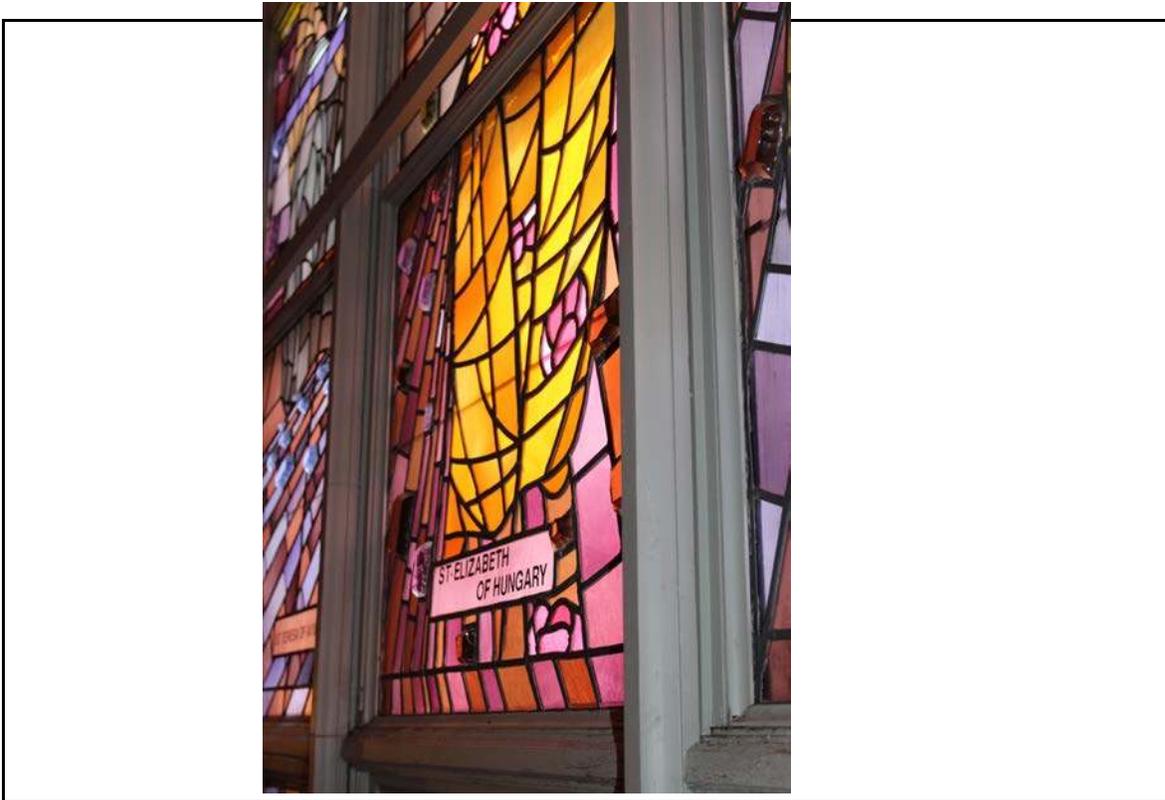
**Photo 26:** Buckeling Stained Glass

| Component | Uniformat Code | Recapitalization Detail | Year of Installation or Repair | Expected Useful Life (EUL) | Current Age | Theoretical Remaining Useful Life (RUL) | Useful Life Corrected For Observations | Year of Replacement | Type of event (Cyclic/Single) | Unit | Quantity | Unit Cost | Total Cost |
|--|---|---|---|---|---|---|--|---|---|---|---|---|---|
| Stained Glass Windows | B2020 - Exterior Windows | Allowance for repair of three observed bowed glass units and inspection of the remaining window | 1984 | 30 | 35 | -5 | 4 | 2023 | Cyclical | Ea | 3 | \$ 4,000.00 | \$ 12,000 |

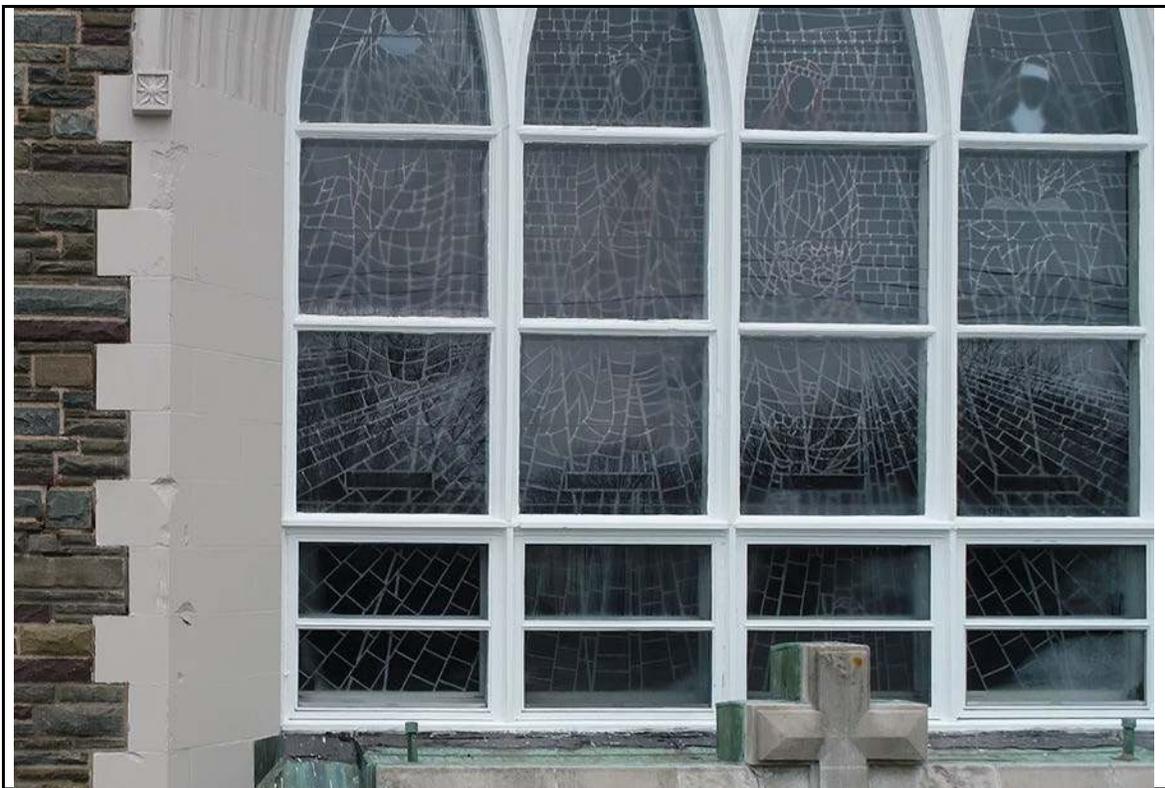
Photo 28: W2 South Elevation Recently Repaired

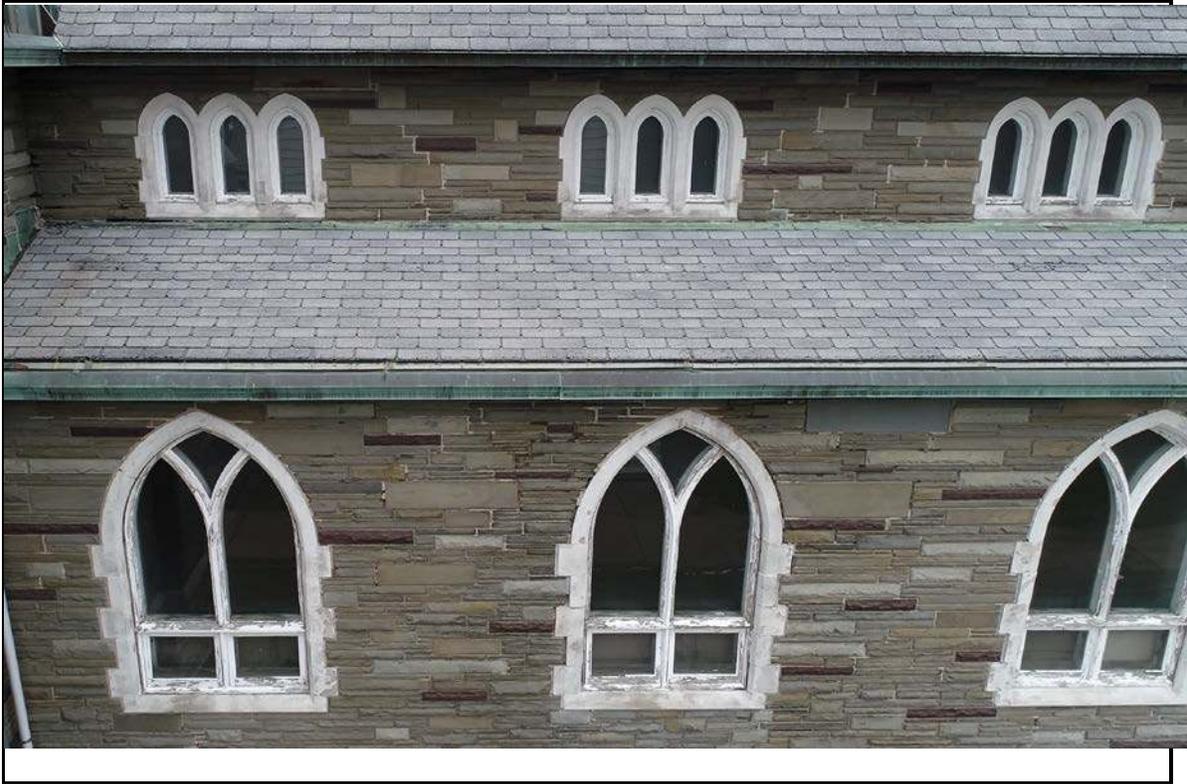
**Photo 29:** W3(lower) & W4(upper) On The East Elevation Typical Condition

| Component | Uniformat Code | Recapitalization Detail | Year of Installation or Repair | Expected Useful Life (EUL) | Current Age | Theoretical Remaining Useful Life (RUL) | Useful Life Corrected For Observations | Year of Replacement | Type of event (Cyclic/Single) | Unit | Quantity | Unit Cost | Total Cost |
|--|---|---|---|---|---|---|--|---|---|---|---|---|---|
| W3 -Main Church Low Level East and West Windows | B2020 - Exterior Windows | Major repair and refurbishment to the wood windows | 1957 | 30 | 62 | -32 | 11 | 2030 | Cyclical | Ea | 12 | \$ 3,000.00 | \$ 36,000 |
| W4 - Main Church High Level East and West Windows | B2020 - Exterior Windows | Major repair and refurbishment to the wood windows | 1957 | 30 | 62 | -32 | 0 | 2019 | Cyclical | Ea | 30 | \$ 1,000.00 | \$ 30,000 |
