## Appendix A – Limited Capital Plan

| Building Name | St. Theresa's Church |

## Appendix B – Photo Log

Project Title:  
**St. THERESA'S CHURCH MASONRY REPAIRS**

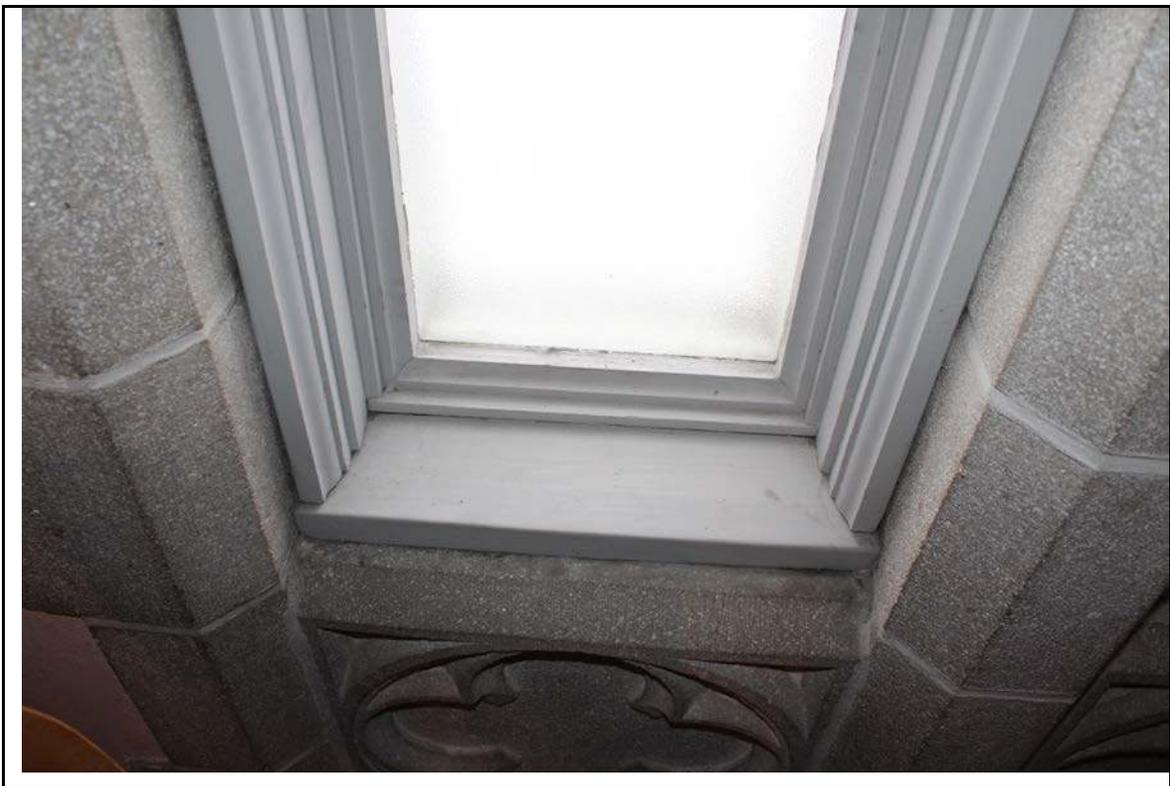
**Photo 32:** W4 Typical Interior Condition As Seen From Gallery

| Component | Uniformat Code | Recapitalization Detail | Year of Installation or Repair | Expected Useful Life (EUL) | Current Age | Theoretical Remaining Useful Life (RUL) | Useful Life Corrected For Observations | Year of Replacement | Type of event (Cyclic/Single) | Unit | Quantity | Unit Cost | Total Cost |
|--|---|---|---|---|---|---|--|---|---|---|---|---|---|
| W4 - Main Church High Level East and West Windows | B2020 - Exterior Windows | Major repair and refurbishment to the wood windows | 1957 | 30 | 62 | -32 | 0 | 2019 | Cyclical | Ea | 30 | \$ 1,000.00 | \$ 30,000 |

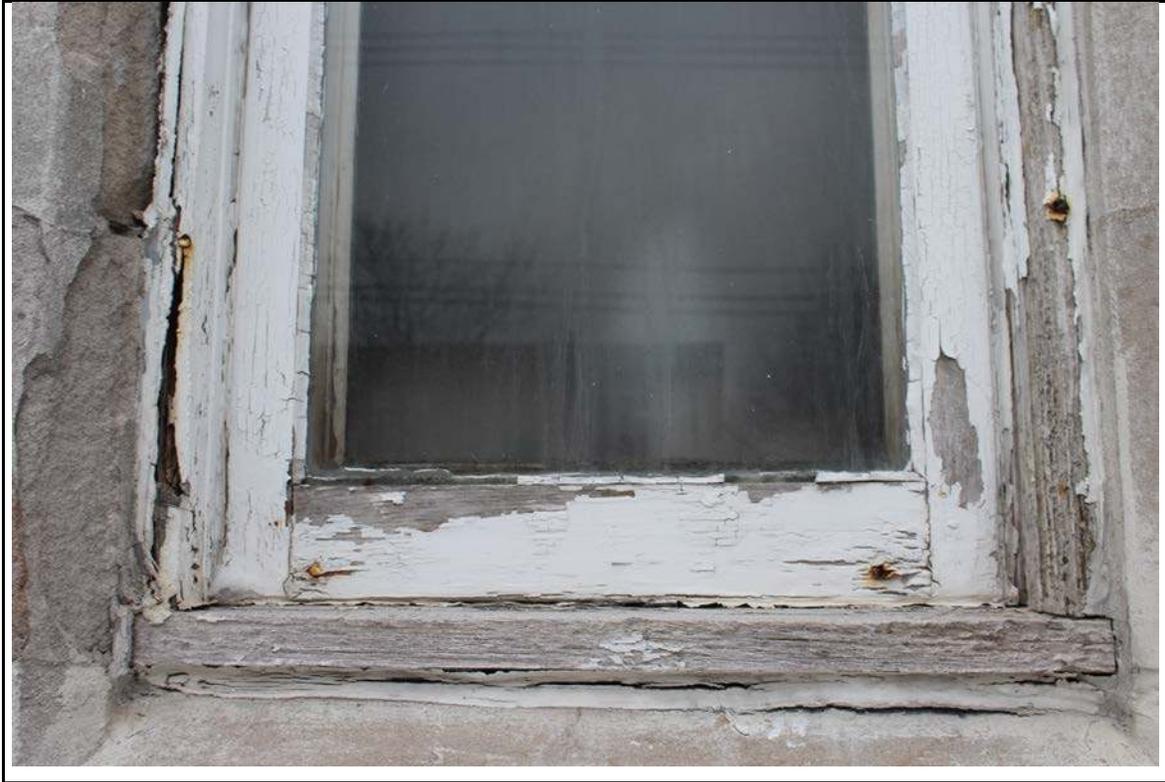
**Photo 33:** W5 South Elevation Window Condition Typical See also Photos 12 and 13

| Component | Uniformat Code | Recapitalization Detail | Year of Installation or Repair | Expected Useful Life (EUL) | Current Age | Theoretical Remaining Useful Life (RUL) | Useful Life Corrected For Observations | Year of Replacement | Type of event (Cyclic/Single) | Unit | Quantity | Unit Cost | Total Cost |
|--|---|---|---|---|---|---|--|---|---|---|---|---|---|
| W5- South Elevation Windows | B2020 - Exterior Windows | Replace deteriorated windows at end of life | 1957 | 30 | 62 | -32 | 0 | 2019 | Cyclical | Ea | 9 | \$ 1,500.00 | \$ 13,500 |

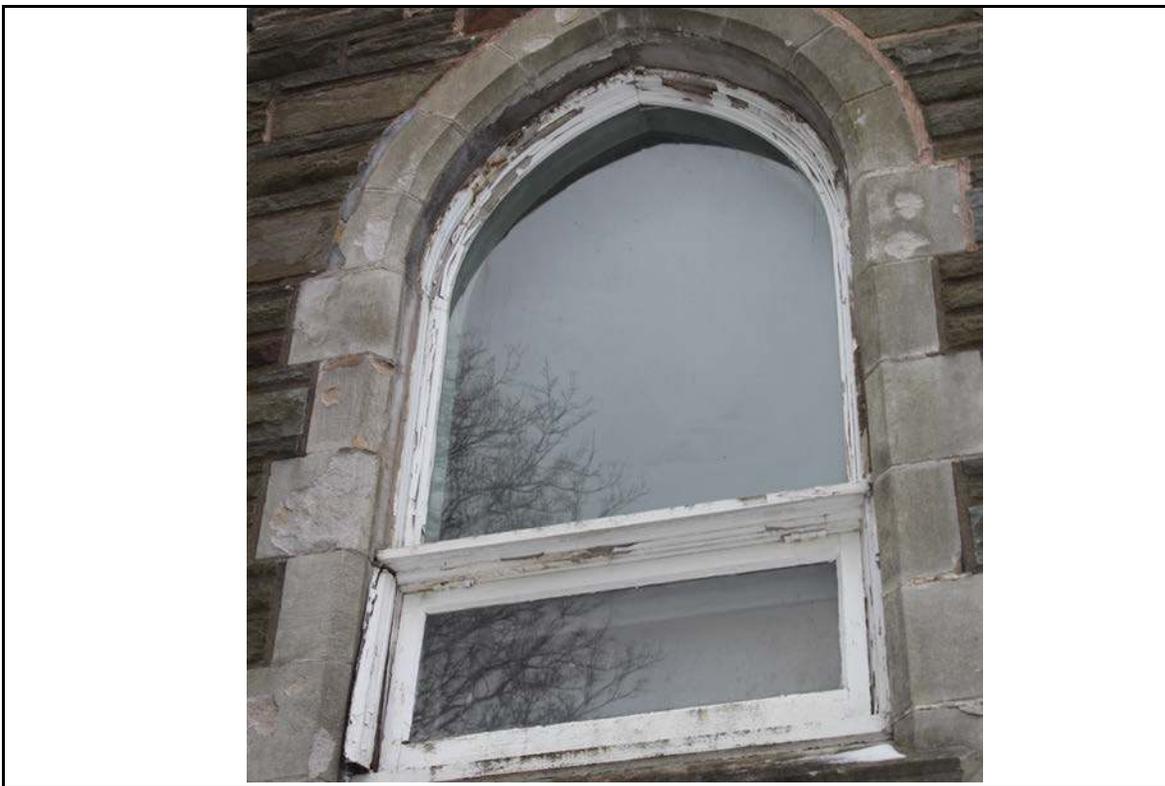
**Photo 34:** W6 East Elevation Window Condition

| Component | Uniformat Code | Recapitalization Detail | Year of Installation or Repair | Expected Useful Life (EUL) | Current Age | Theoretical Remaining Useful Life (RUL) | Useful Life Corrected For Observations | Year of Replacement | Type of event (Cyclic/Single) | Unit | Quantity | Unit Cost | Total Cost |
|--|---|---|---|---|---|---|--|---|---|---|---|---|---|
| W6 - Chapel Windows | B2020 - Exterior Windows | Replace deteriorated windows at end of life | 1957 | 30 | 62 | -32 | 2 | 2021 | Cyclical | Ea | 5 | \$ 5,000.00 | \$ 25,000 |

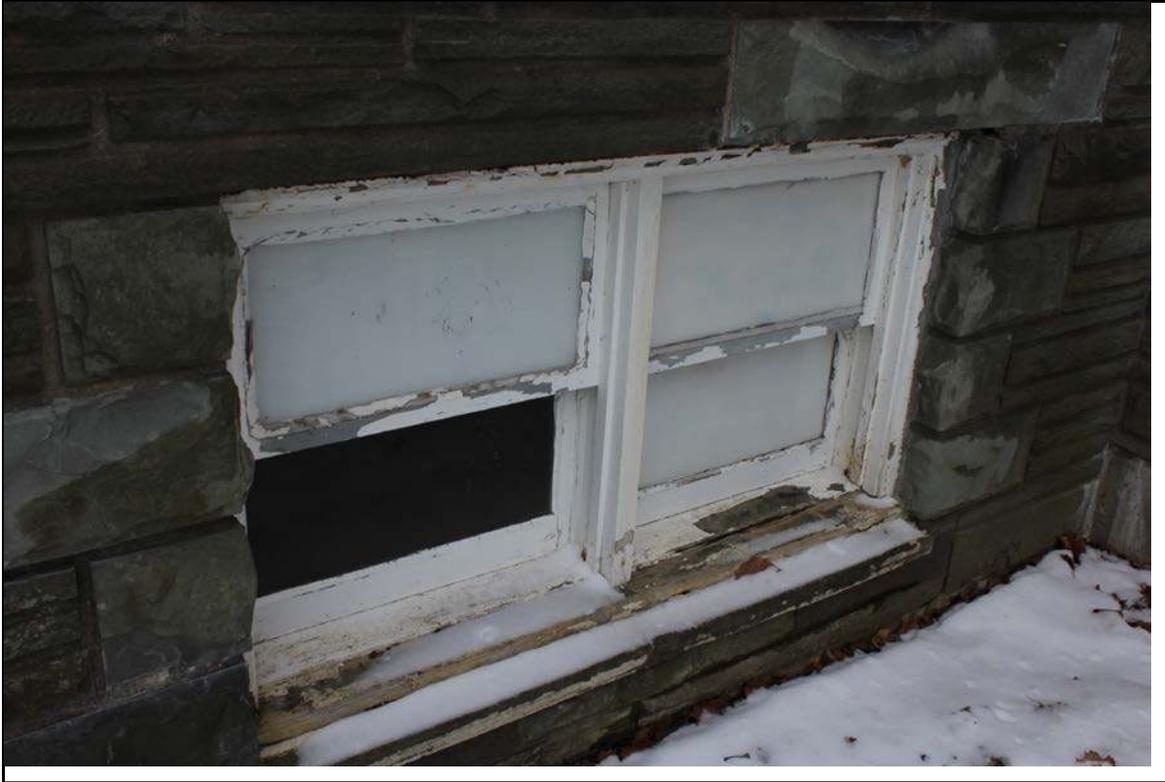
**Photo 35:** W7 Window Condition

| Component | Uniformat Code | Recapitalization Detail | Year of Installation or Repair | Expected Useful Life (EUL) | Current Age | Theoretical Remaining Useful Life (RUL) | Useful Life Corrected For Observations | Year of Replacement | Type of event (Cyclic/Single) | Unit | Quantity | Unit Cost | Total Cost |
|--|---|---|---|---|---|---|--|---|---|---|---|---|---|
| W7- Boiler and East Stair Windows | B2020 - Exterior Windows | Replace deteriorated windows at end of life | 1957 | 30 | 62 | -32 | 0 | 2019 | Cyclical | Ea | 5 | \$ 3,000.00 | \$ 15,000 |

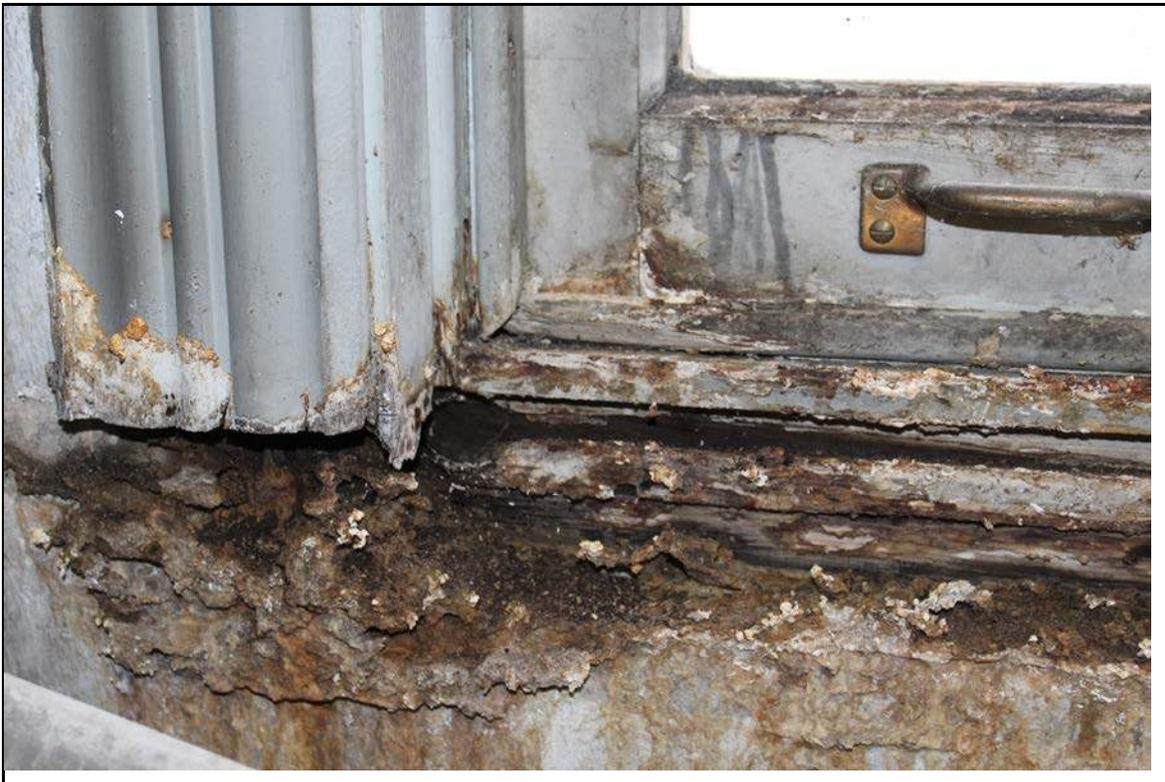
**Photo 36:** W7 Interior Window Condition

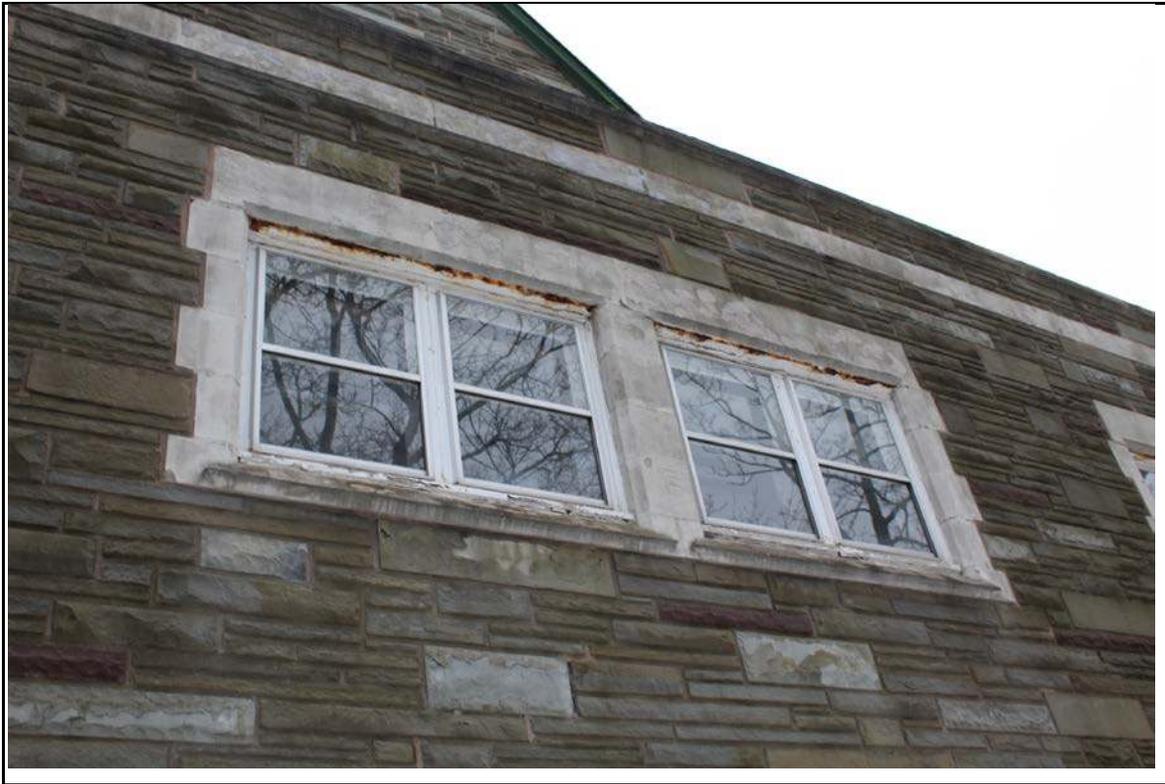
**Photo 37:** W8 Window Condition

| Component | Uniformat Code | Recapitalization Detail | Year of Installation or Repair | Expected Useful Life (EUL) | Current Age | Theoretical Remaining Useful Life (RUL) | Useful Life Corrected For Observations | Year of Replacement | Type of event (Cyclic/Single) | Unit | Quantity | Unit Cost | Total Cost |
|--|---|---|---|---|---|---|--|---|---|---|---|---|---|
| <b>W8- North Wing Main and Fair Condition Basement Level Windows</b> | B2020 - Exterior Windows | Repair and refurbishment fair condition windows | 1957 | 30 | 62 | -32 | 4 | 2023 | Cyclical | Ea | 14 | \$ 1,000.00 | \$ 14,000 |

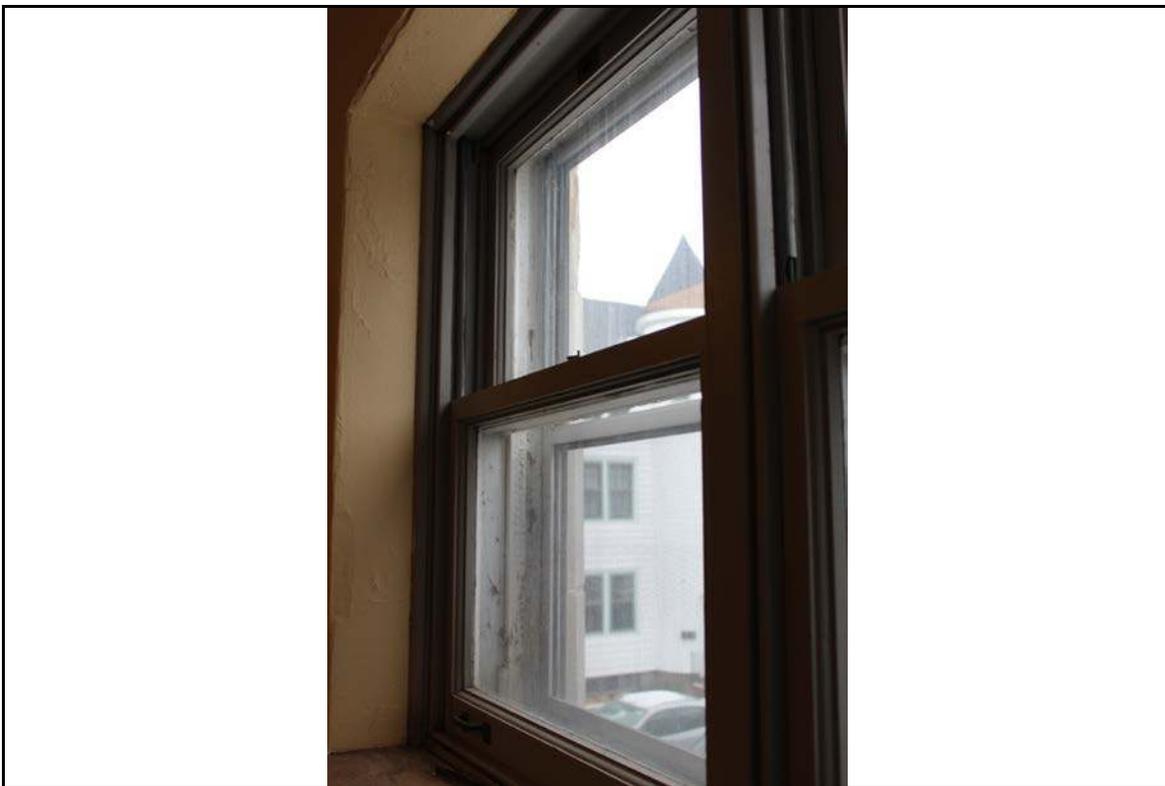
**Photo 38:** W8 Interior Window Condition

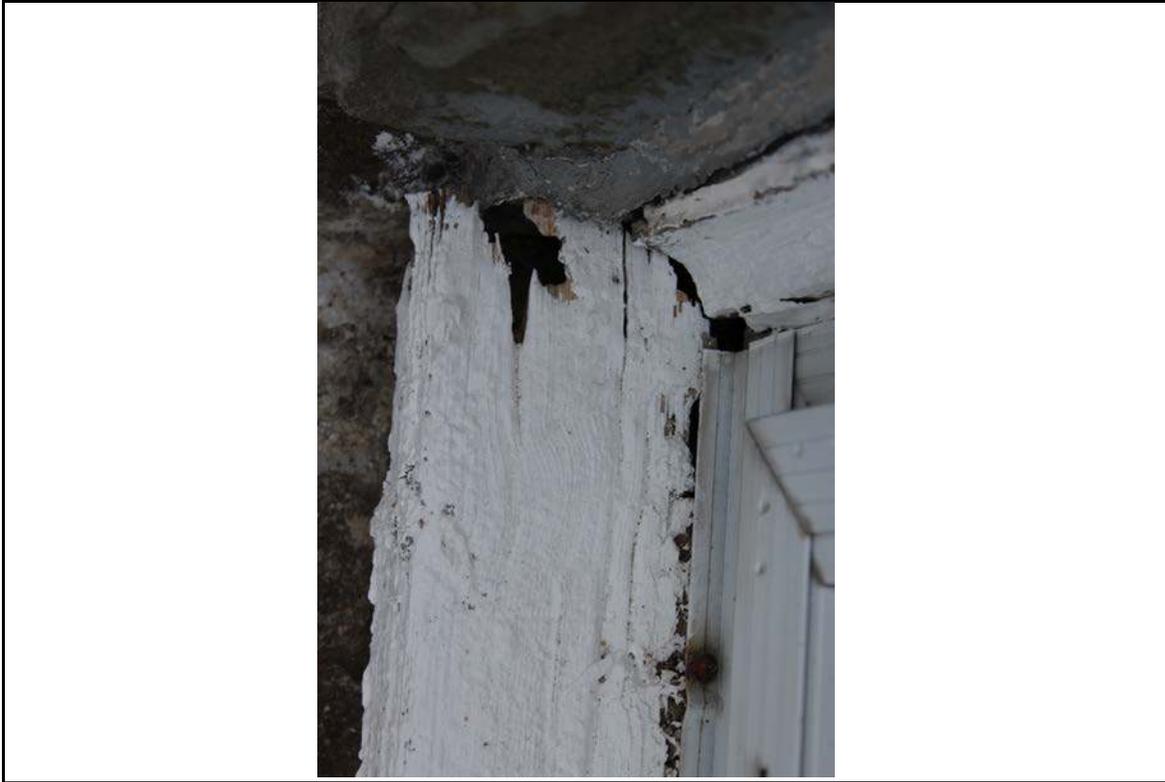
**Photo 39:** W9 Window Condition

| Component | Uniformat Code | Recapitalization Detail | Year of Installation or Repair | Expected Useful Life (EUL) | Current Age | Theoretical Remaining Useful Life (RUL) | Useful Life Corrected For Observations | Year of Replacement | Type of event (Cyclic/Single) | Unit | Quantity | Unit Cost | Total Cost |
|--|---|---|---|---|---|---|--|---|---|---|---|---|---|
| <b>W9- West Elevation Basement Level Windows</b> | B2020 - Exterior Windows | Replace deteriorated windows at end of life | 1957 | 30 | 62 | -32 | 0 | 2019 | Cyclical | Ea | 4 | \$ 2,000.00 | \$ 8,000 |

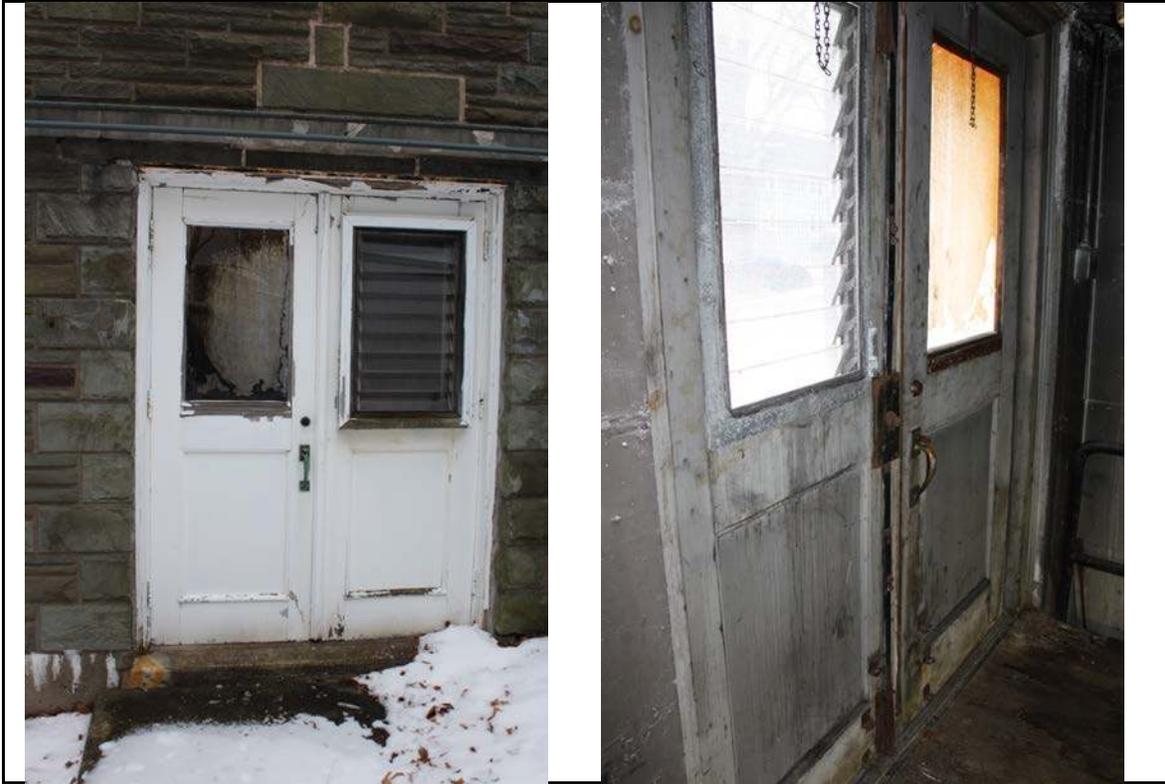
**Photo 43:** Boiler Room Door Condition Exterior Left Interior To The Right

| Component | Uniformat Code | Recapitalization Detail | Year of Installation or Repair | Expected Useful Life (EUL) | Current Age | Theoretical Remaining Useful Life (RUL) | Useful Life Corrected For Observations | Year of Replacement | Type of event (Cyclic/Single) | Unit | Quantity | Unit Cost | Total Cost |
|--|---|---|---|---|---|---|--|---|---|---|---|---|---|
| <b>Mechanical Room Wood Doors</b> | B2030 - Exterior Doors | Replace deteriorated wood doors with metal doors | 1957 | 40 | 62 | -22 | 0 | 2019 | Cyclical | Ea | 2 | \$ 1,800.00 | \$ 3,600 |

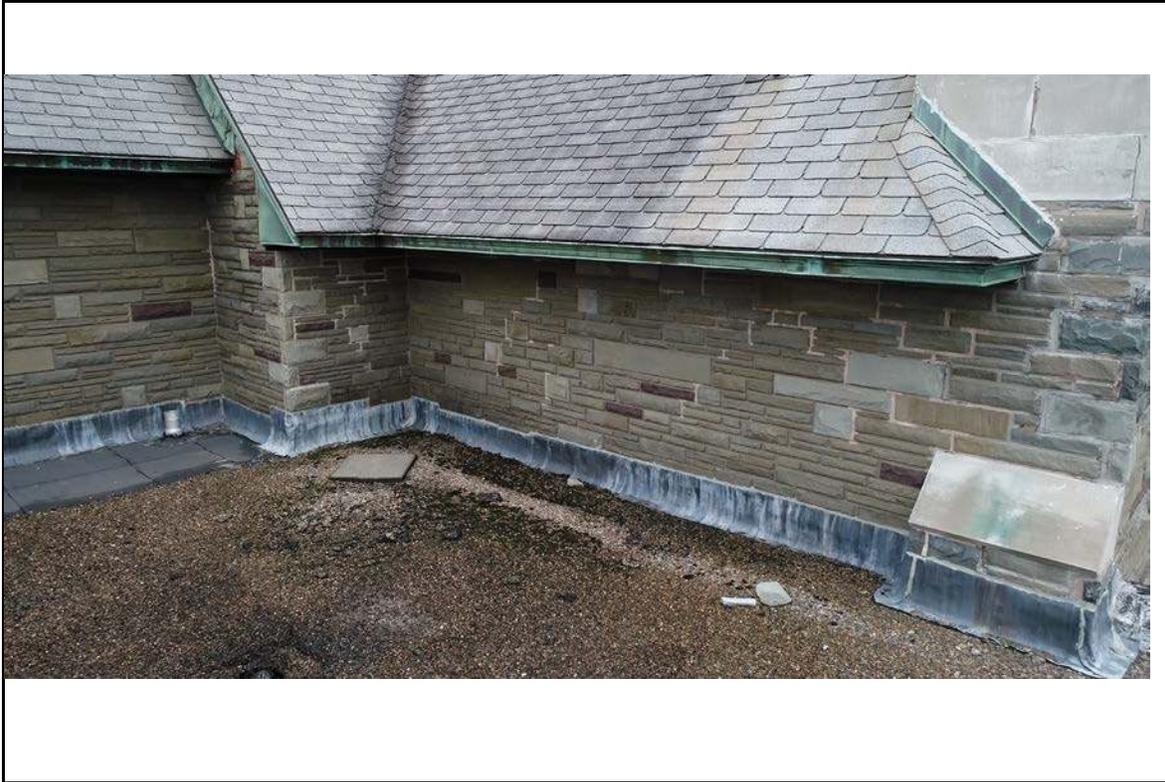
**Photo 45:** Built Up Roof West Side Organic Matter, Large Debris and Blueberrying

| Component | Uniformat Code | Recapitalization Detail | Year of Installation or Repair | Expected Useful Life (EUL) | Current Age | Theoretical Remaining Useful Life (RUL) | Useful Life Corrected For Observations | Year of Replacement | Type of event (Cyclic/Single) | Unit | Quantity | Unit Cost | Total Cost |
|--|---|---|---|---|---|---|--|---|---|---|---|---|---|
| <b>Flat Roof - Replace BUR</b> | B3010 - Roof Coverings | Remove and replace flat roof and address ponding | 1980 | 20 | 39 | -19 | 0 | 2019 | Cyclical | ft <sup>2</sup> | 2,530 | \$ 18.00 | \$ 45,540 |

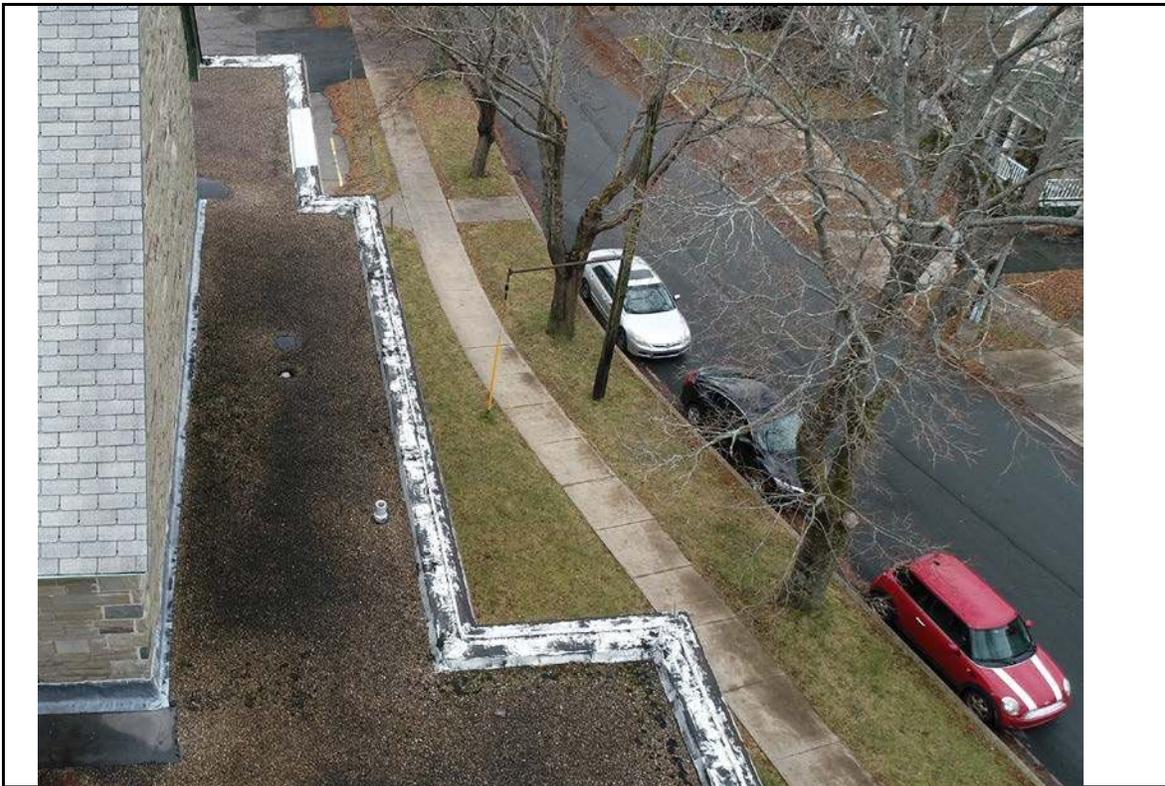
**Photo 46:** Built Up Roof North Side Blueberrying

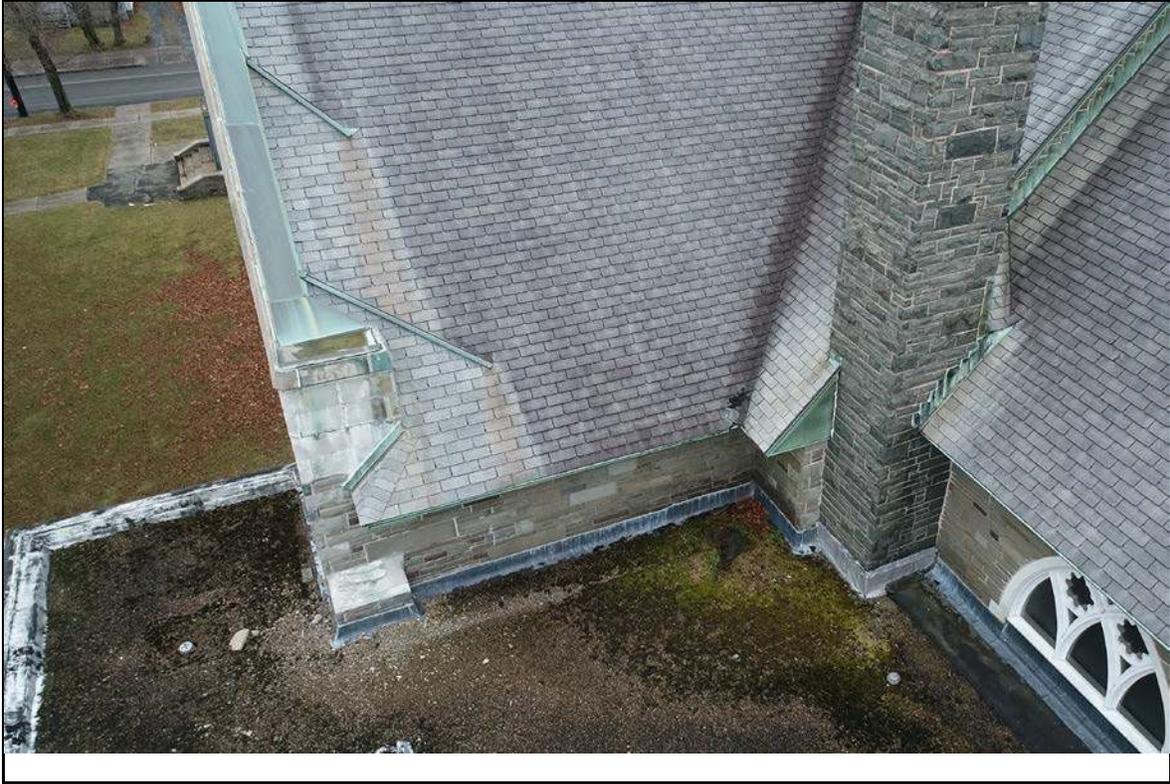
**Photo 47:** Built Up Roof East Side Organic Matter and Blueberrying

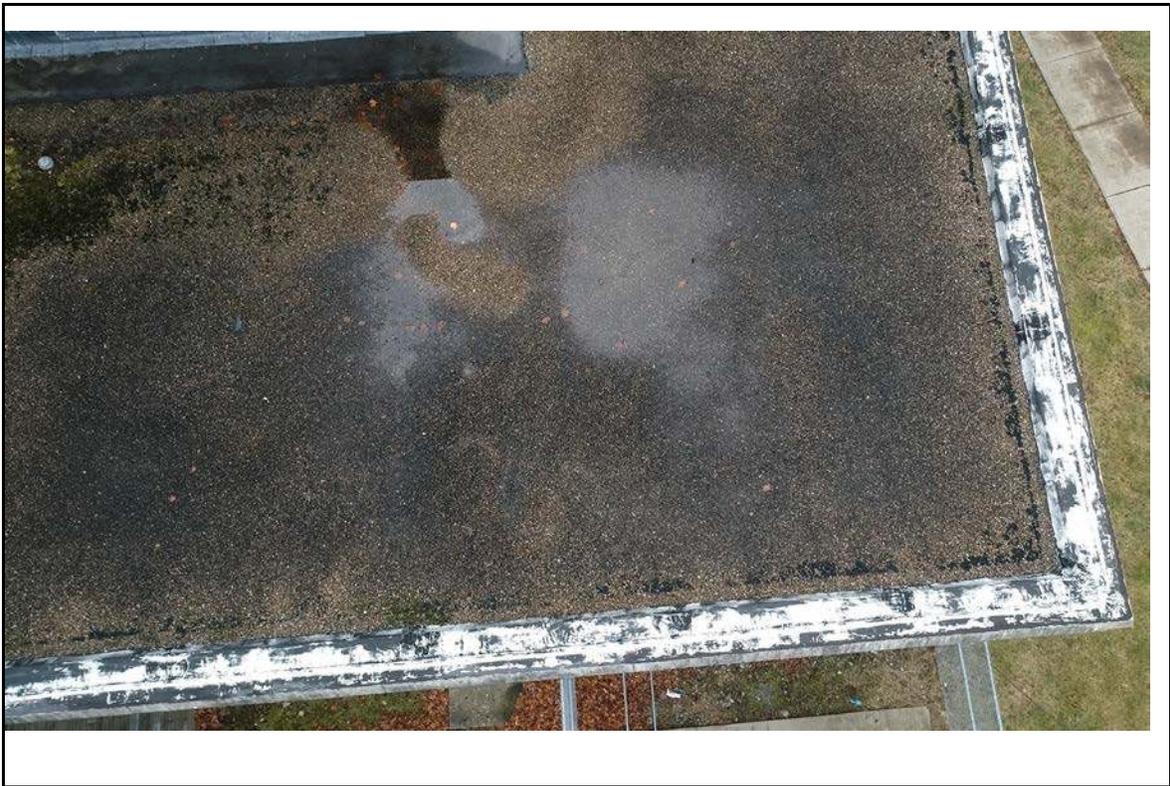
**Photo 48:** Built Up Roof North Side Ponding and Blueberrying

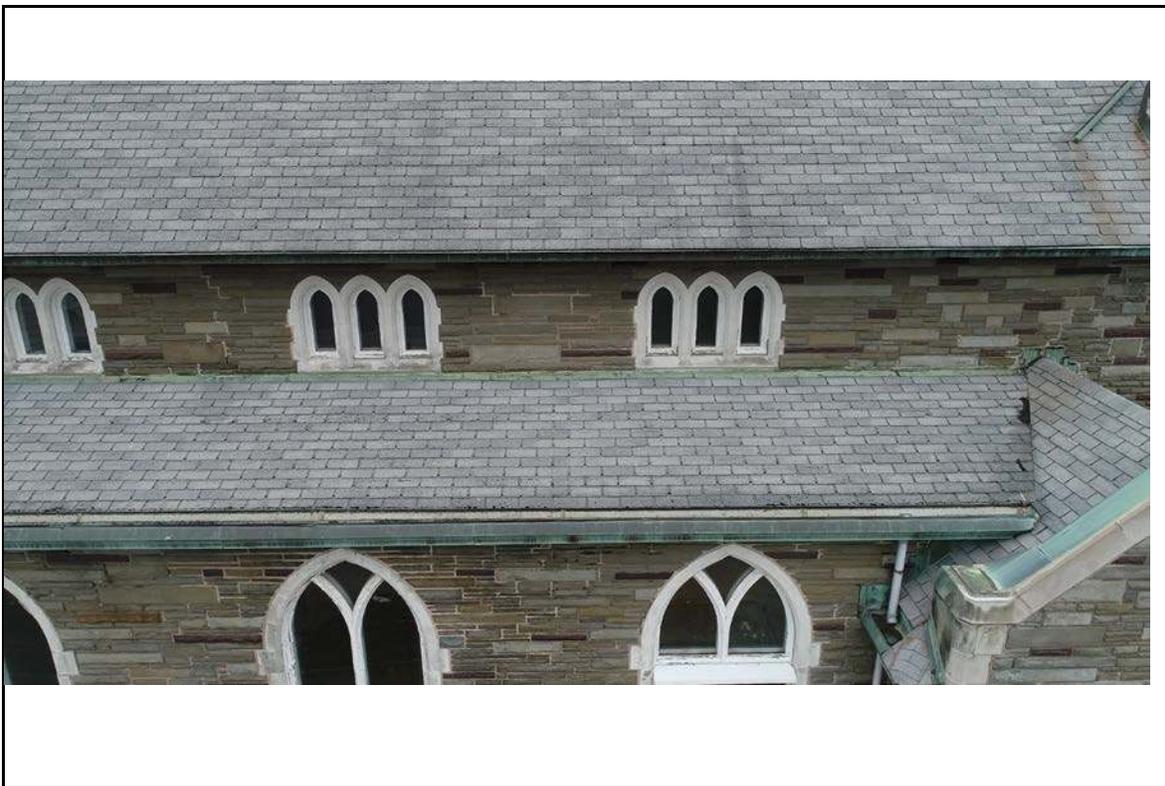
**Photo 50:** Asphalt Shingles At Lower Roof Drip Line

| Component | Uniformat Code | Recapitalization Detail | Year of Installation or Repair | Expected Useful Life (EUL) | Current Age | Theoretical Remaining Useful Life (RUL) | Useful Life Corrected For Observations | Year of Replacement | Type of event (Cyclic/Single) | Unit | Quantity | Unit Cost | Total Cost |
|--|---|---|---|---|---|---|--|---|---|---|---|---|---|
| <b>Asphalt Roof- Low Roof Areas Replacement</b> | B3010 - Roof Coverings | Replace low roofs prior to main church due to accelerated deterioration from drip edge of main roof | 2009 | 20 | 10 | 10 | 8 | 2027 | Cyclical | ft <sup>2</sup> | 1,285 | \$ 4.50 | \$ 5,783 |
