RE: *Structural Review of St. Theresa's Church Block Walls*

Campbell Comeau Engineering Limited has carried out a structural review of the exterior masonry walls of Saint Theresa's Church. The review focused upon the condition of the concrete block walls and the connection of the walls to the concrete frame at the exterior of the church. This report provides the findings of our on-site investigation which involved making 16 openings in the exterior walls.

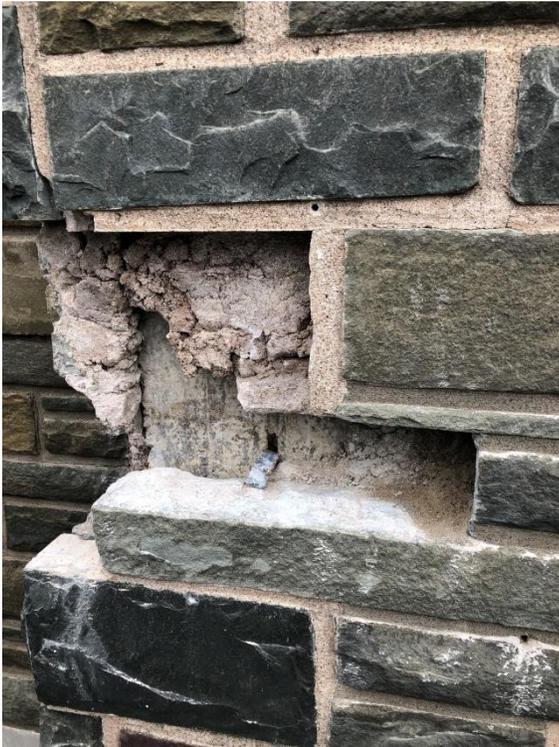
Photo No. 8 – Opening 1 – Concrete column and dovetail slot and anchor visible.

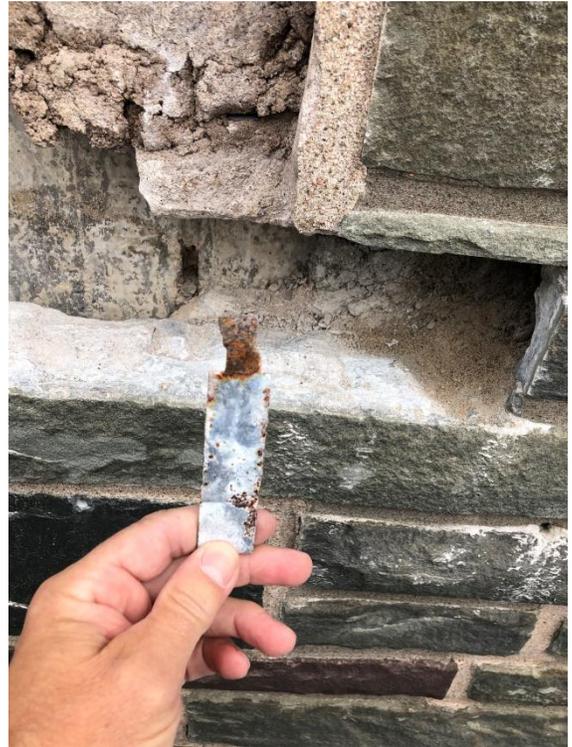
Photo No. 9 – Opening 1 – Tail of dovetail tie corroded and partially cut away.

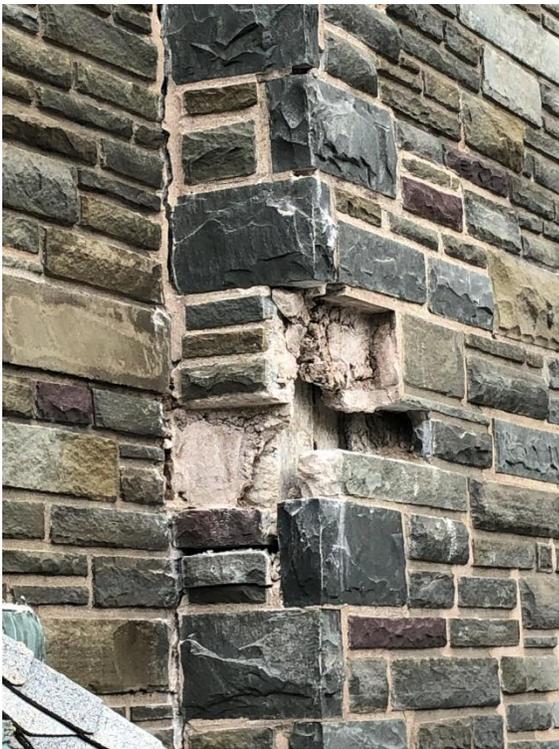
Photo No. 10 – Opening 1 – Column and mortar filled cavity.

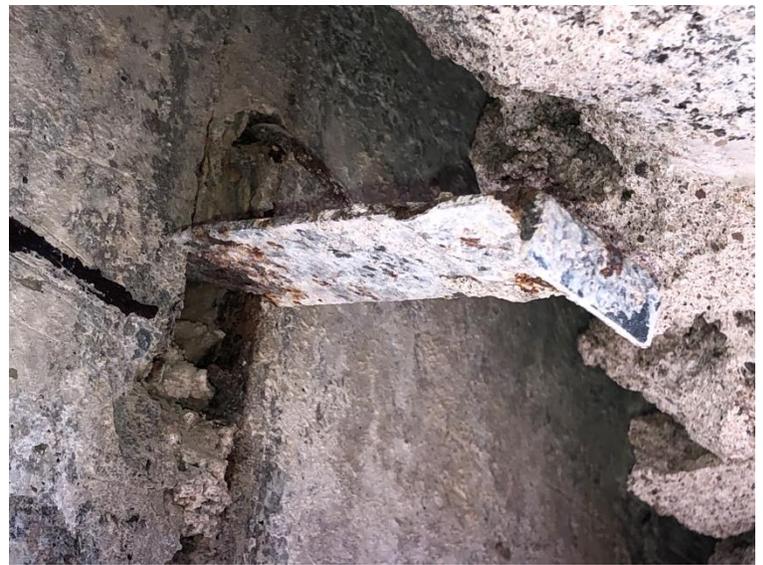
Photo No. 11 – Opening 1 – view of dovetail anchor in slot. Surface corrosion on anchor projection. Greater corrosion on tail of anchor.

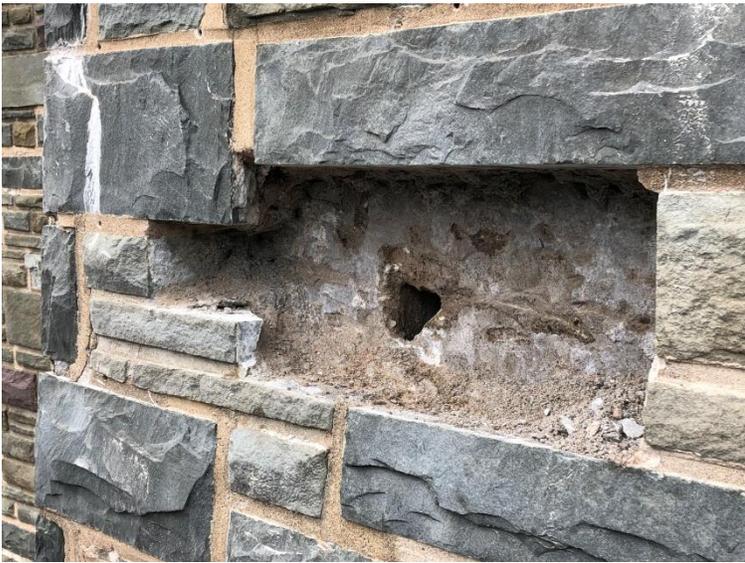
Photo No. 12 – Opening 2 – Masonry wall observed at bell tower base. Concrete column not located. Mortar filled cavity.

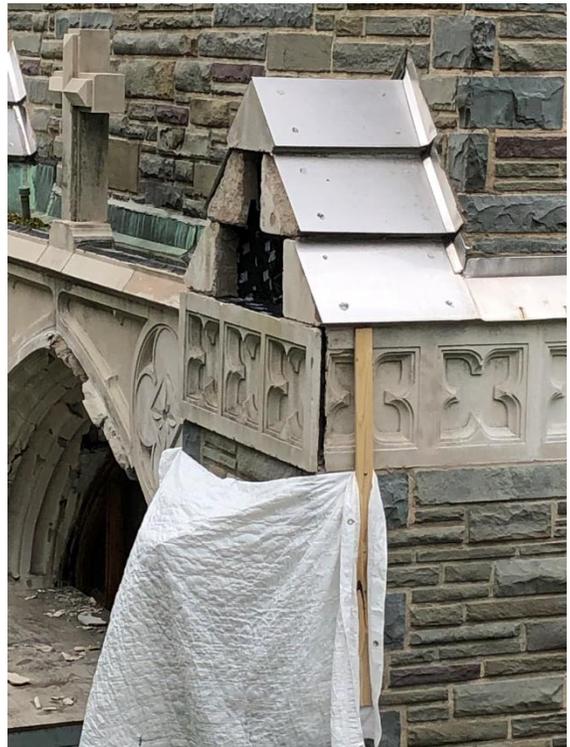
The windows of the church feature precast concrete jambs, sill and arch sections. These pieces of precast extend from the exterior through to the interior of the wall. Deterioration of a number of these elements has taken place. The most extensive example of the deterioration is on the front entrance east side door. This existing detail will be a consideration in any wall renewal planning.

Photo No. 13– Opening 3 – Area of opening at east entry. Note displaced precast at base of opening. Temporary flashing in place. Note deteriorated precast at entrance arch.

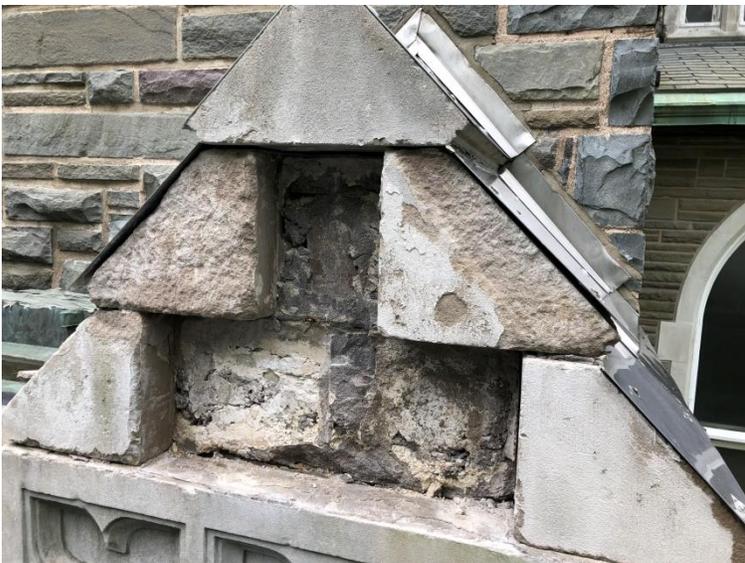
Photo No. 14 – Opening 3 – Block masonry infill in place behind precast. Mortar filled cavity.

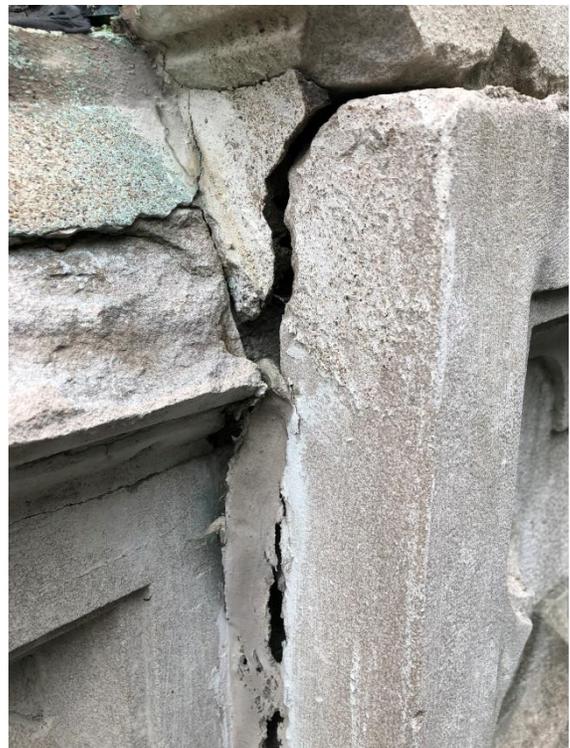
Photo No. 15 – Opening 3 – Displaced precast with open joint. No precast ties to back up observed.

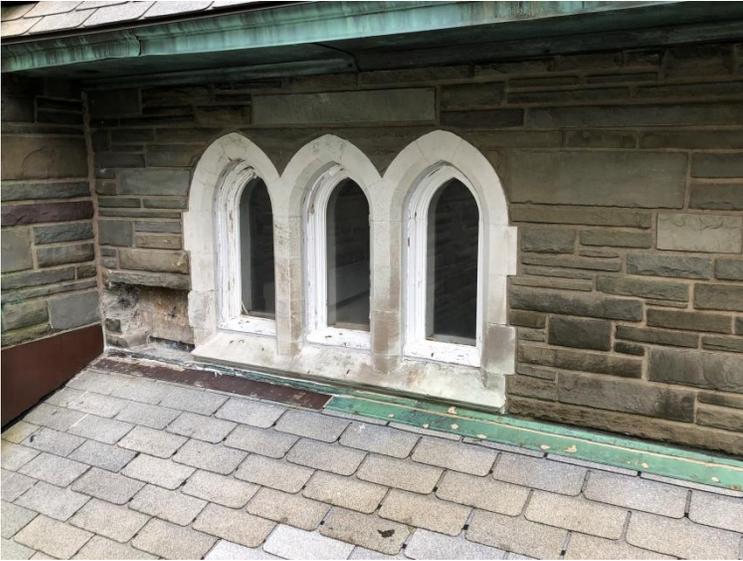
Photo No. 16 – Opening 4 – Opening at inside corner at rear of Church. Block wall observed.

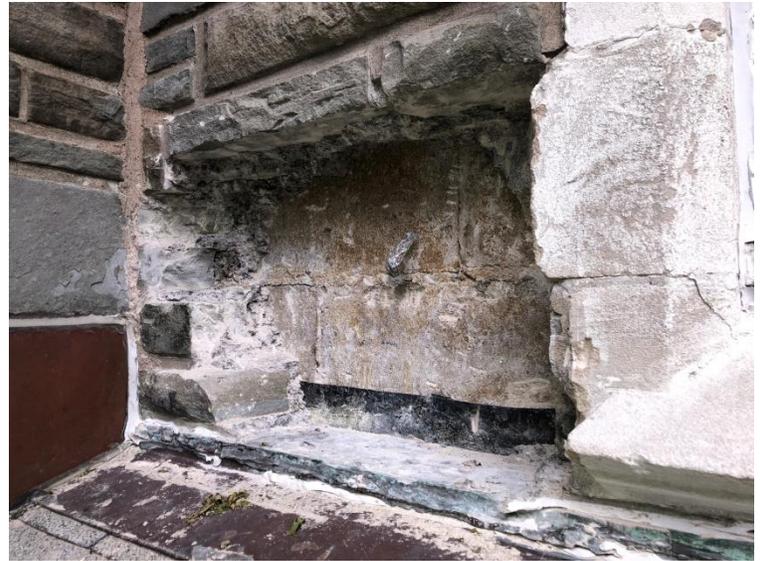
Photo No. 17 – Opening 4 – Block wall with corroded strip tie visible. Concrete column not observed. Through-wall flashing in place.

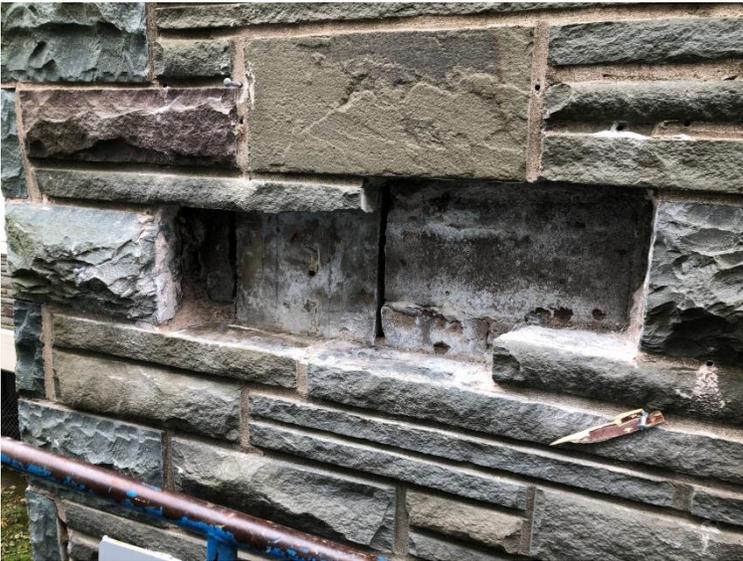
Photo No. 18 – Opening 5 – Concrete column at corner. Dovetail slot in place.

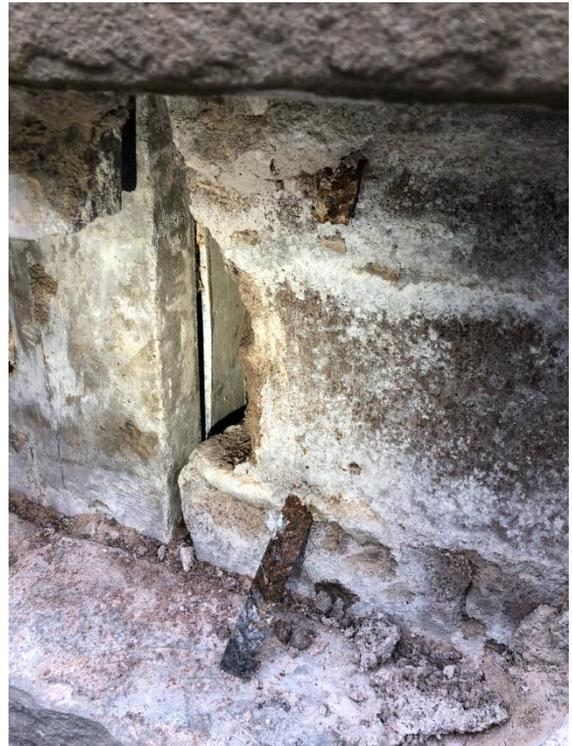
Photo No. 19 – Opening 5 – Mortar filled cavity. Corroded strip tie visible. Dovetail slot in column face.

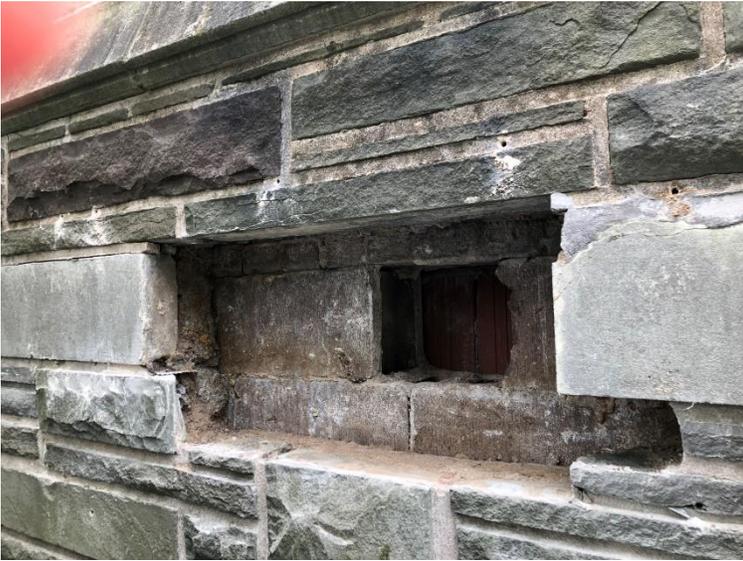
Photo No. 20 – Opening 6 – Opening above east Elevation window. Corroded strip ties observed. Clay “speed tile” in interior wall observed.

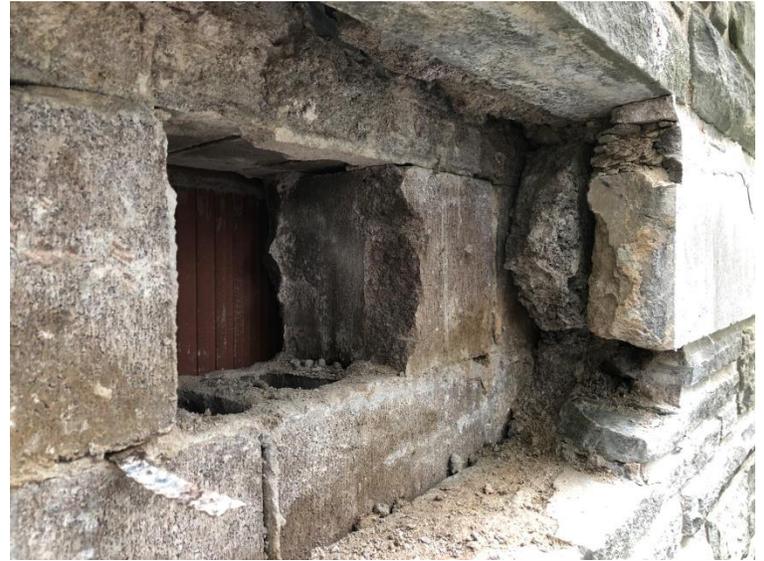
Photo No. 21 – Opening 6 – Block wall with strip tie. Mortar filled cavity.

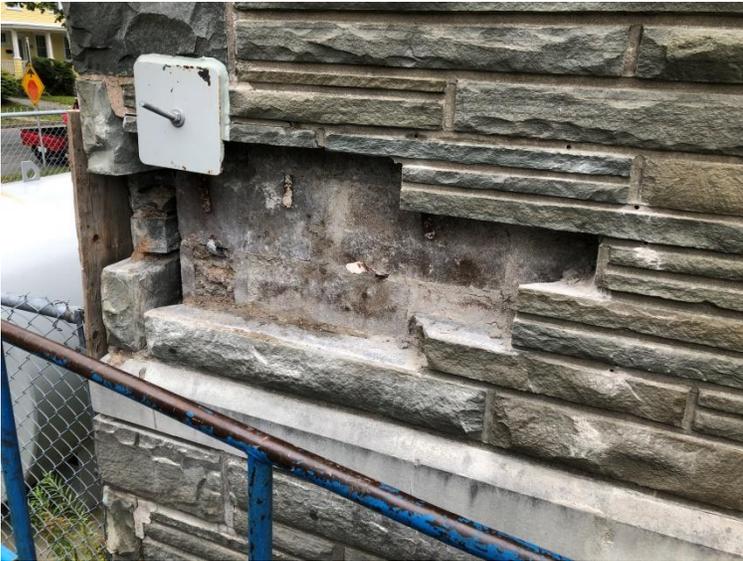
Photo No. 22 – Opening 7 – Block bearing wall in place with no concrete corner column.

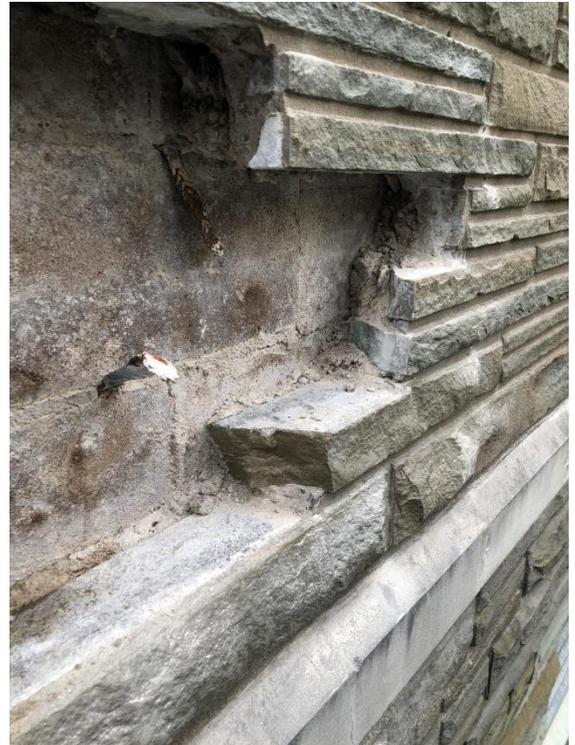
Photo No. 23 – Opening 7 – Mortar filled cavity and corroded strip ties.

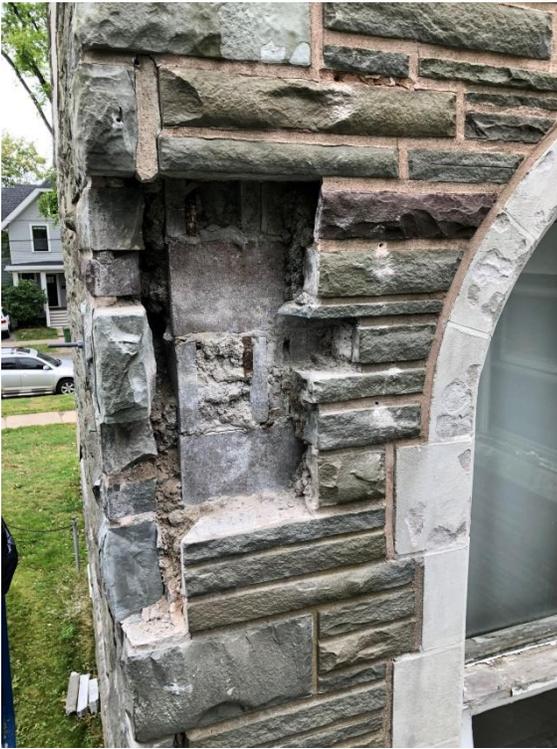
Photo No. 24 - Opening 8 – Block bearing wall in place. No concrete column. Corroded strip tie in masonry filled cavity.

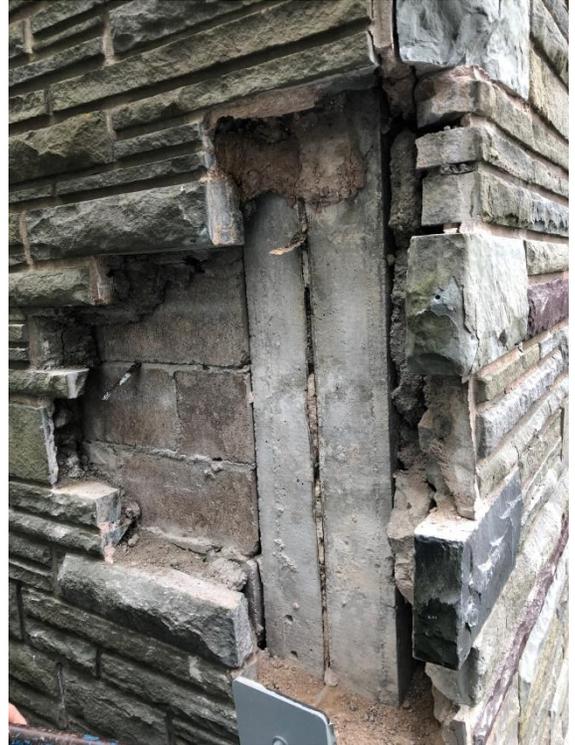
Photo No. 25 - Opening 9 – Dovetail slot on face of column not on side facing block wall. Surface corrosion on anchors. Corroded strip tie at face of brick.

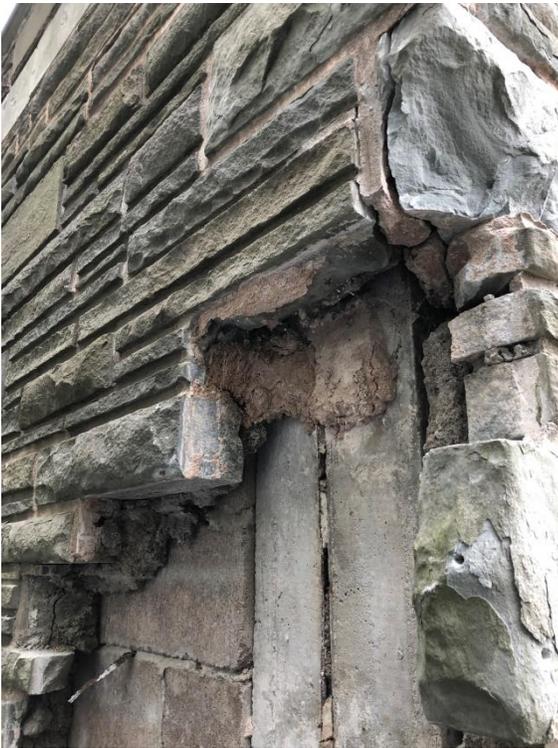
Photo No. 26 - Opening 9 – View of column and cavity is filled with mortar.

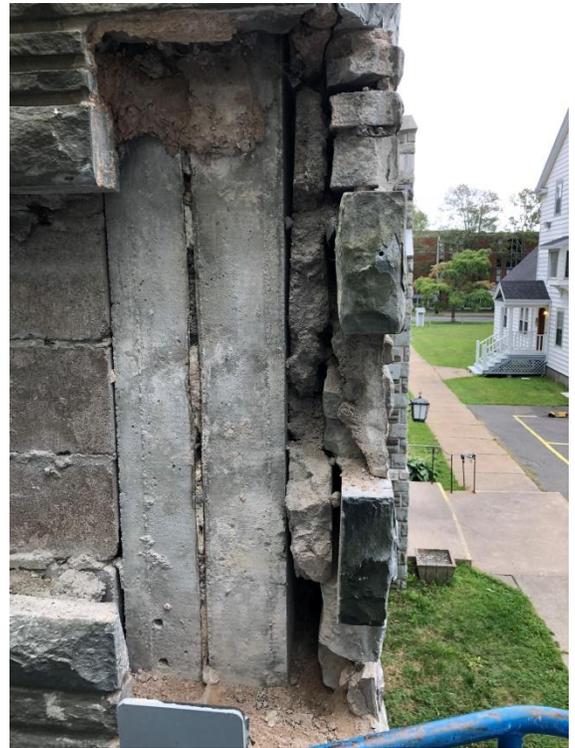
Photo No. 27 - Opening 9 – View of cavity with mortar fill.

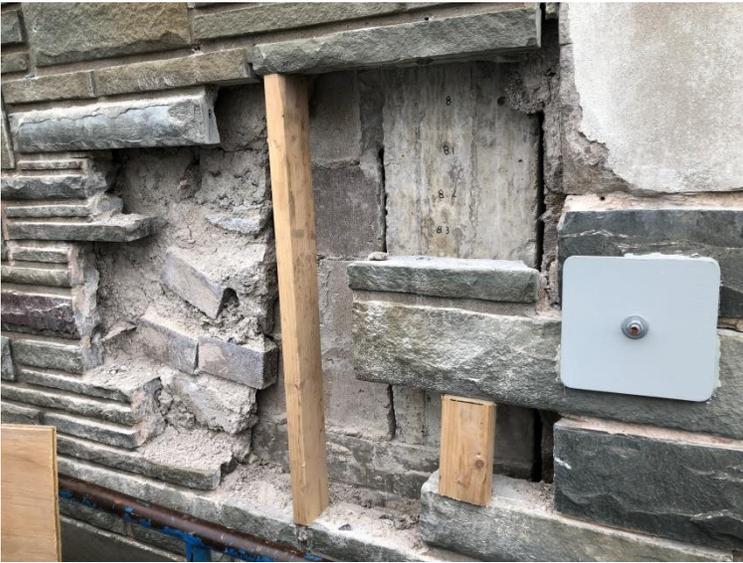
Photo No. 28 - Opening 10 - View of concrete column, block wall and filled cavity (note sloping “bricks”).

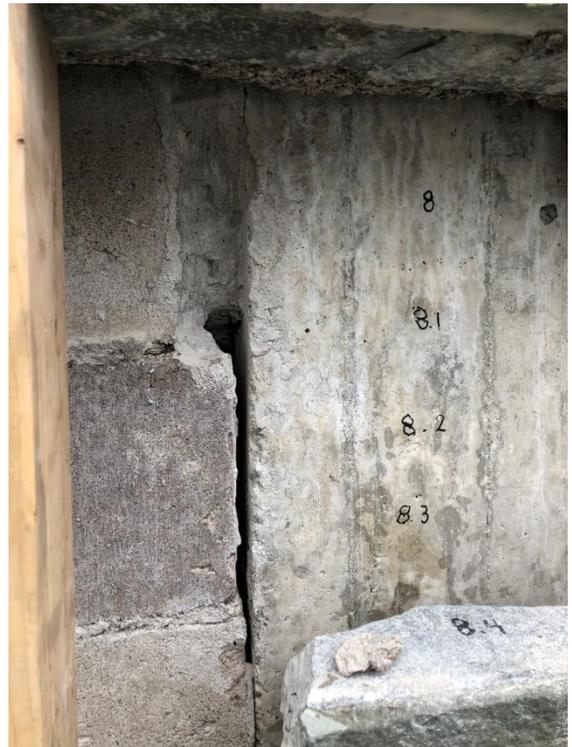
Photo No. 29 - Opening 10 - Block wall to concrete column junction. No dovetail slot or block anchors observed.

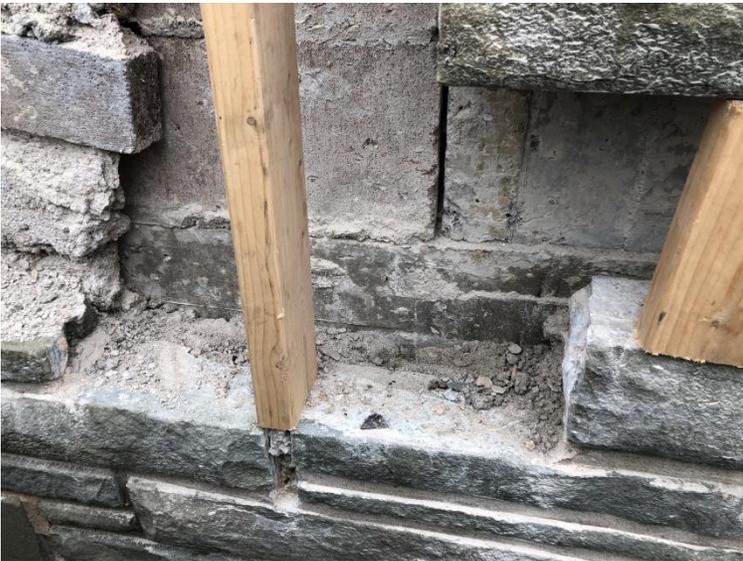
Photo No. 30 - Opening 10 – Concrete beam at base of opening.

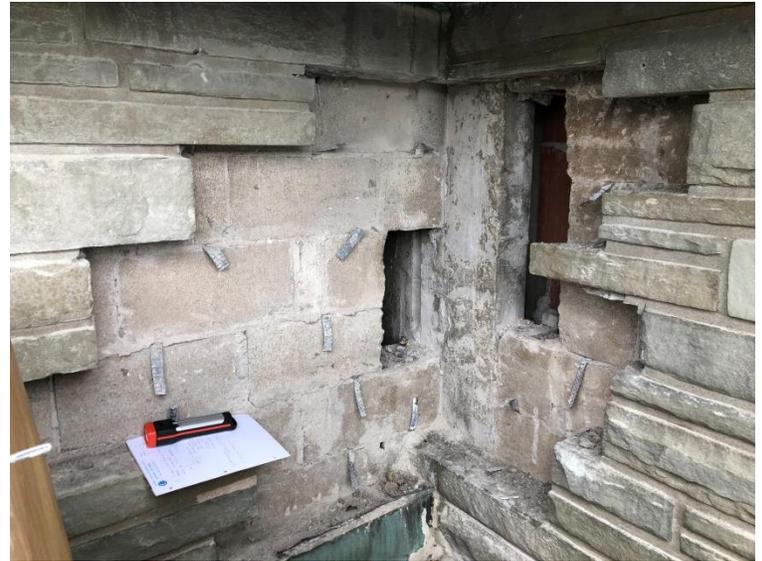
Photo No. 31 - Opening 11 – Corner area. Corner column visible. No dovetail slots. Strip ties to veneer visible.

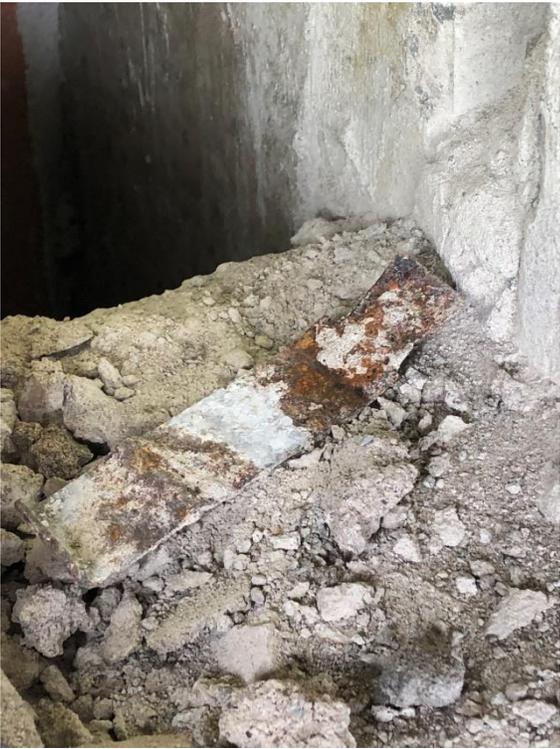
Photo No. 32 - Opening 11 – Dovetail tie at column chamfer. Corroded tail section.

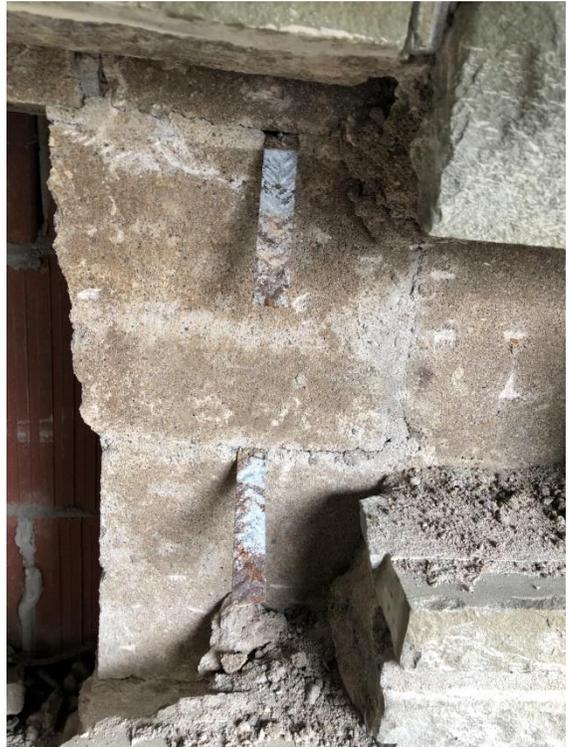
The Wall Section and Plan Detail in the upper right hand corner of Drawing SW-1 indicates the anticipated layout of the dovetail ties and the positioning of them. During the construction of the formwork for the concrete columns a dovetail shaped slot is installed into the formwork. The slot is revealed when the formwork is removed and the dovetail anchors are installed as the concrete block wall is constructed. Ties are also placed in the concrete block to connect the 4" stone facing to the concrete block. These ties are different from the dovetail anchor ties. A number of these ties, known as "corrugated strip ties", were observed in the openings made through the wall. Photo No. 33 shows a close view of the corrugated strip ties.

Photo No. 33 - Opening 11 – Strip ties in cavity. Corrosion of the surfaces. Mortar filled cavity.

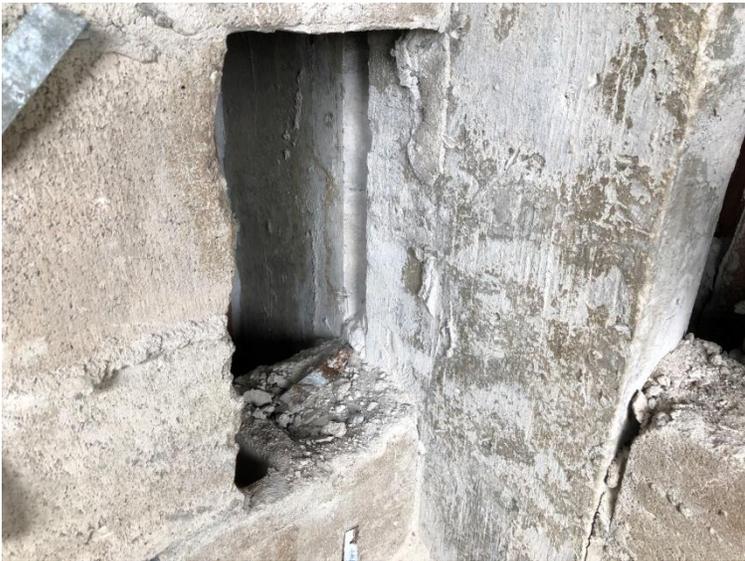
Photo No. 34 - Opening 11 – Column chamfer used as tie "slot".

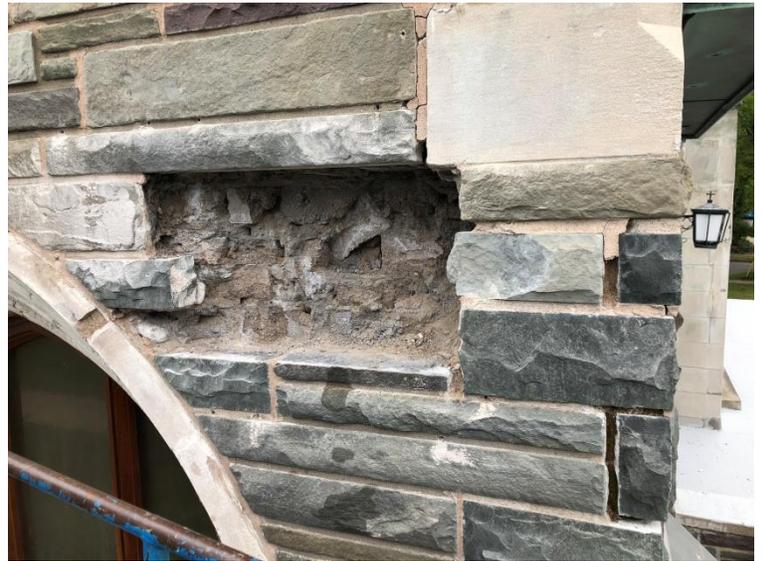
Photo No. 35 - Opening 12 – Above west entrance. Block bearing wall. No column present.

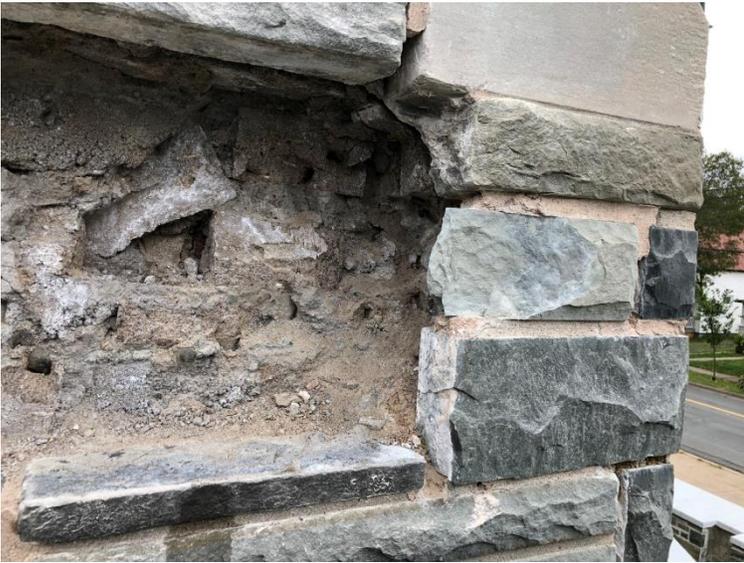
Photo No. 36 - Opening 12- Filled cavity at opening, "rubble masonry".

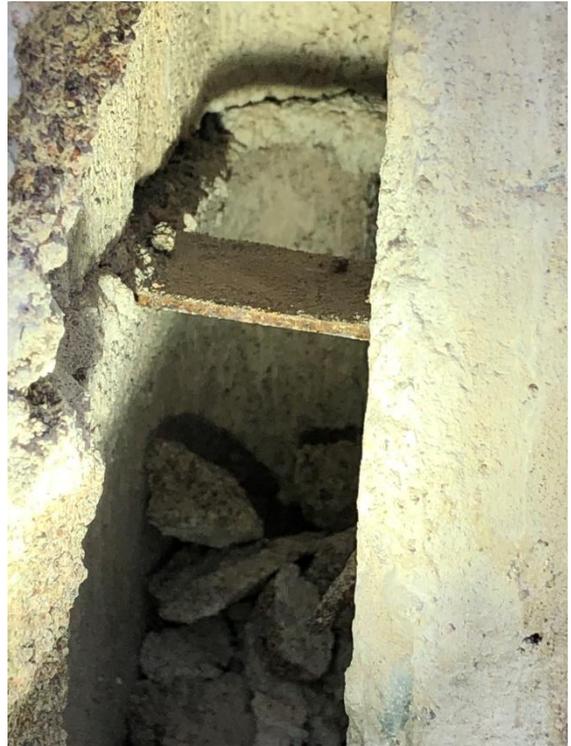
Photo No. 37 - Opening 13 – Anchor in block wall. No mortar present in cavity.

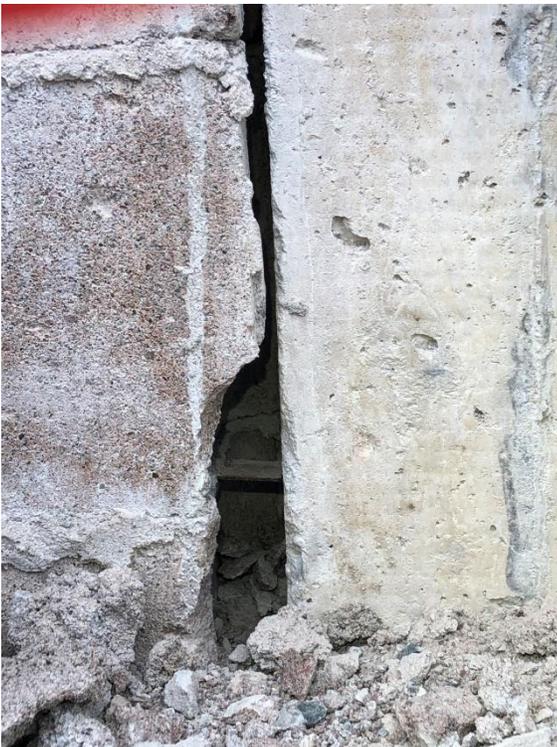
Photo No. 38 - Opening 13 – Anchor in cavity. Block wall to column interface.

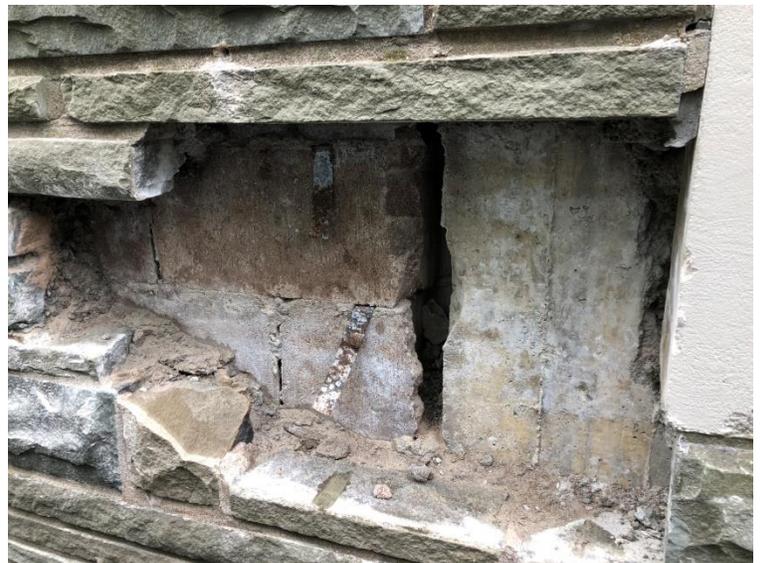
Photo No. 39 - Opening 14 – At precast window jamb. Corroded strip ties observed. Dovetail slot present in concrete column. No dovetail ties in place. Concrete column chipped away on right side to provide clearance for precast at window jamb.

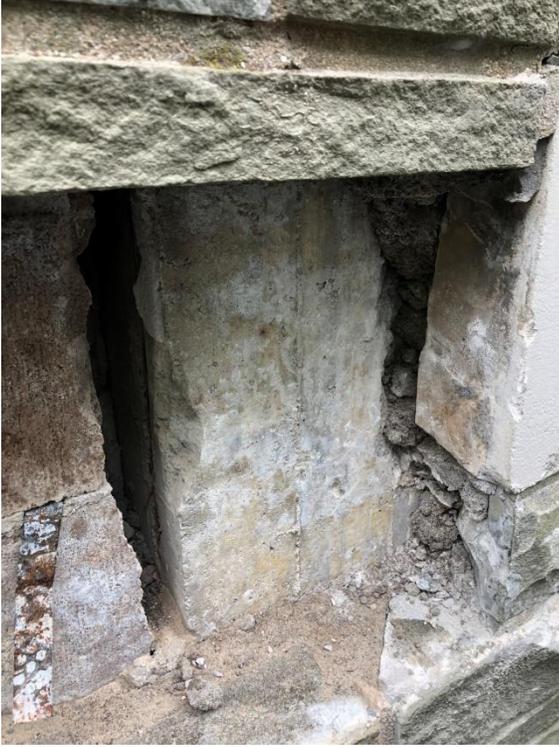
Photo No. 40 - Opening 14 – Exposed concrete column mortar filled cavity.

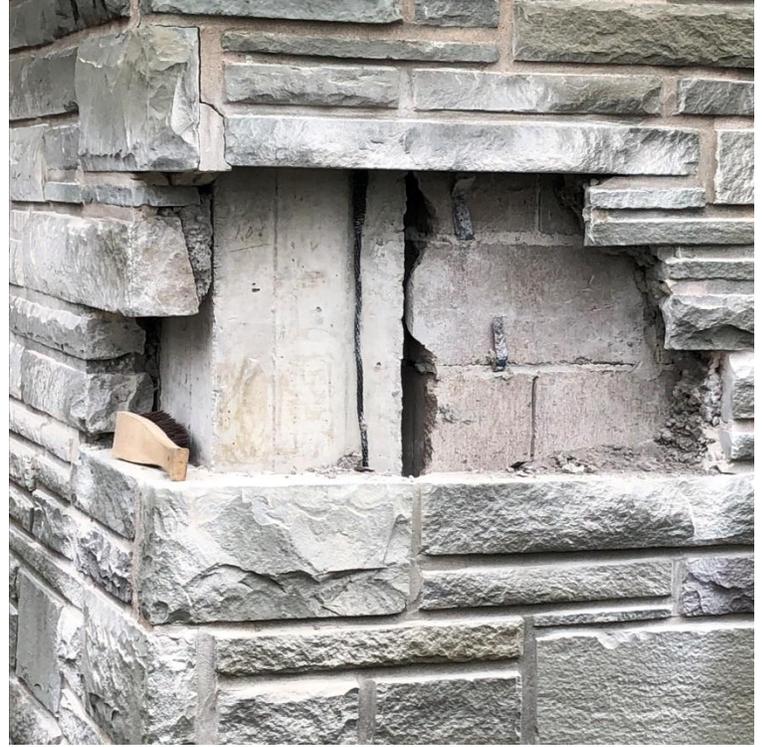
Photo No. 41 - Opening 15 – Column at corner of wall. Corroded strip ties observed.

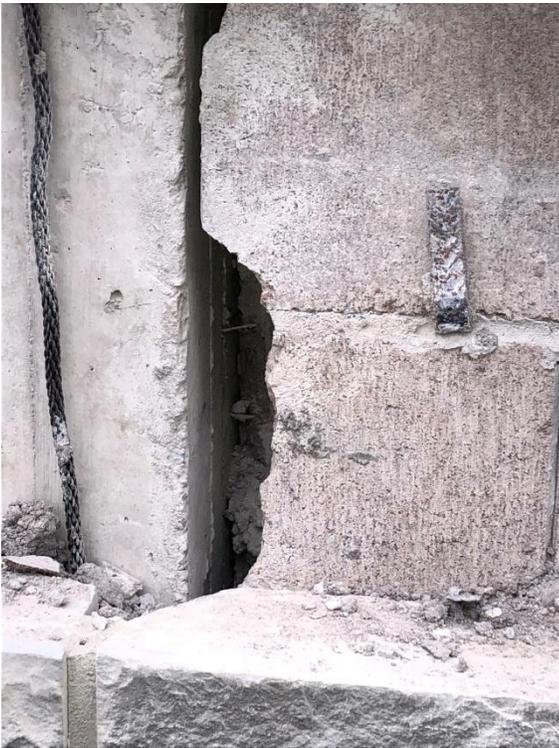
Photo No. 42 - Opening 15 – Dovetail slot present in column face at brick wall.

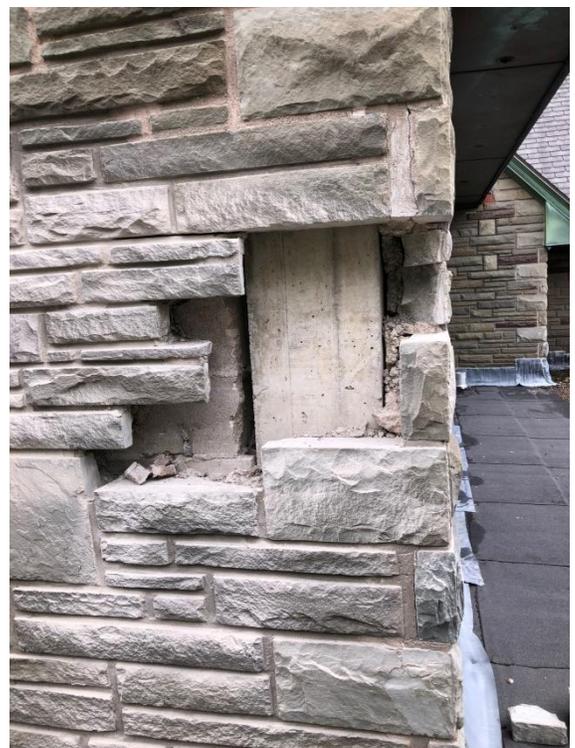
Photo No. 43 - Opening 16 – Column at corner of wall. Dovetail slot present on block wall face of column. No dovetail ties observed.

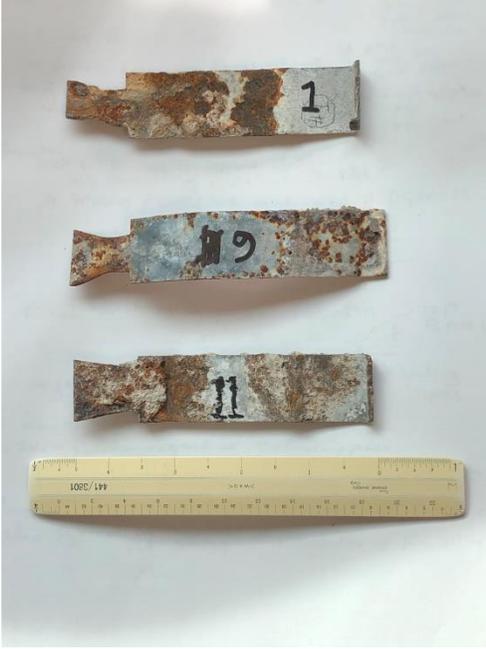
Photograph Nos. 1 to 7 show the various elevations of the church for reference. Photographs Nos. 8 through 33 illustrate the condition of the back-up wall and any concrete columns present within the 16 observation openings. Photograph No. 44 shows three of the dovetail anchors found during the investigation. It can be noted that surface corrosion is present on all three of these anchors

indicating that the protective galvanized coating has been essentially consumed. Going forward, corrosion of the anchors will continue and this will take place at an increasing rate.

Photo No. 44 – Photograph of three dovetail anchors with opening number indicated.
